Avoid irregular and  
discontinuous systems

# ตัวอย่างความไม่ต่อเนื่องของโครงสร้างในแนวดิ่ง (จาก มยพ.1301-50 กรมโยธาธิการและผังเมือง)

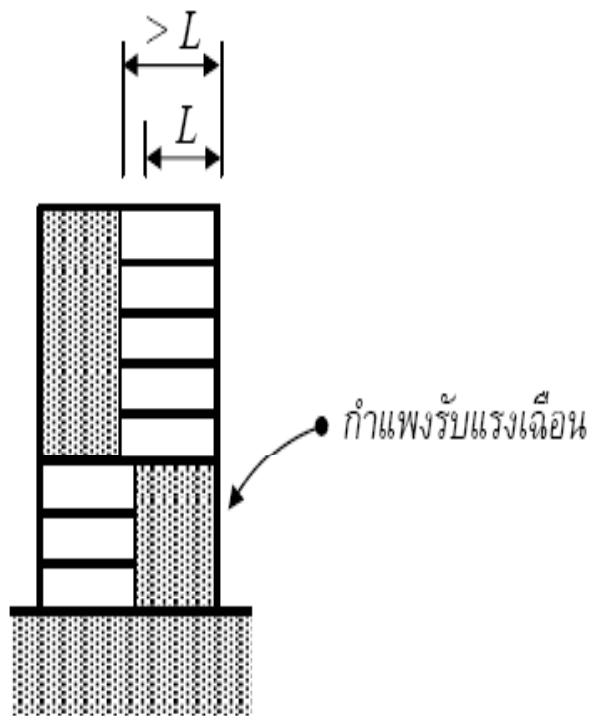
ความไม่ต่อเนื่องในระนาบ

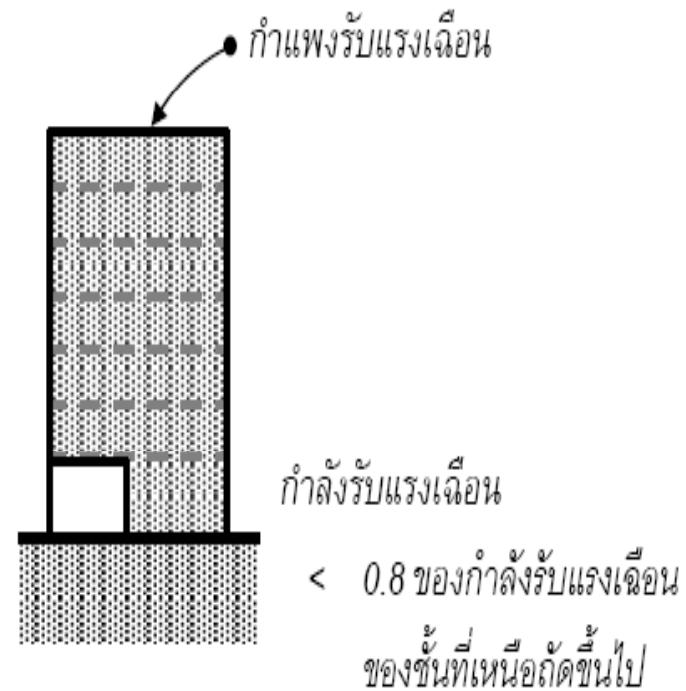
ความไม่ต่อเนื่องของกำลัง

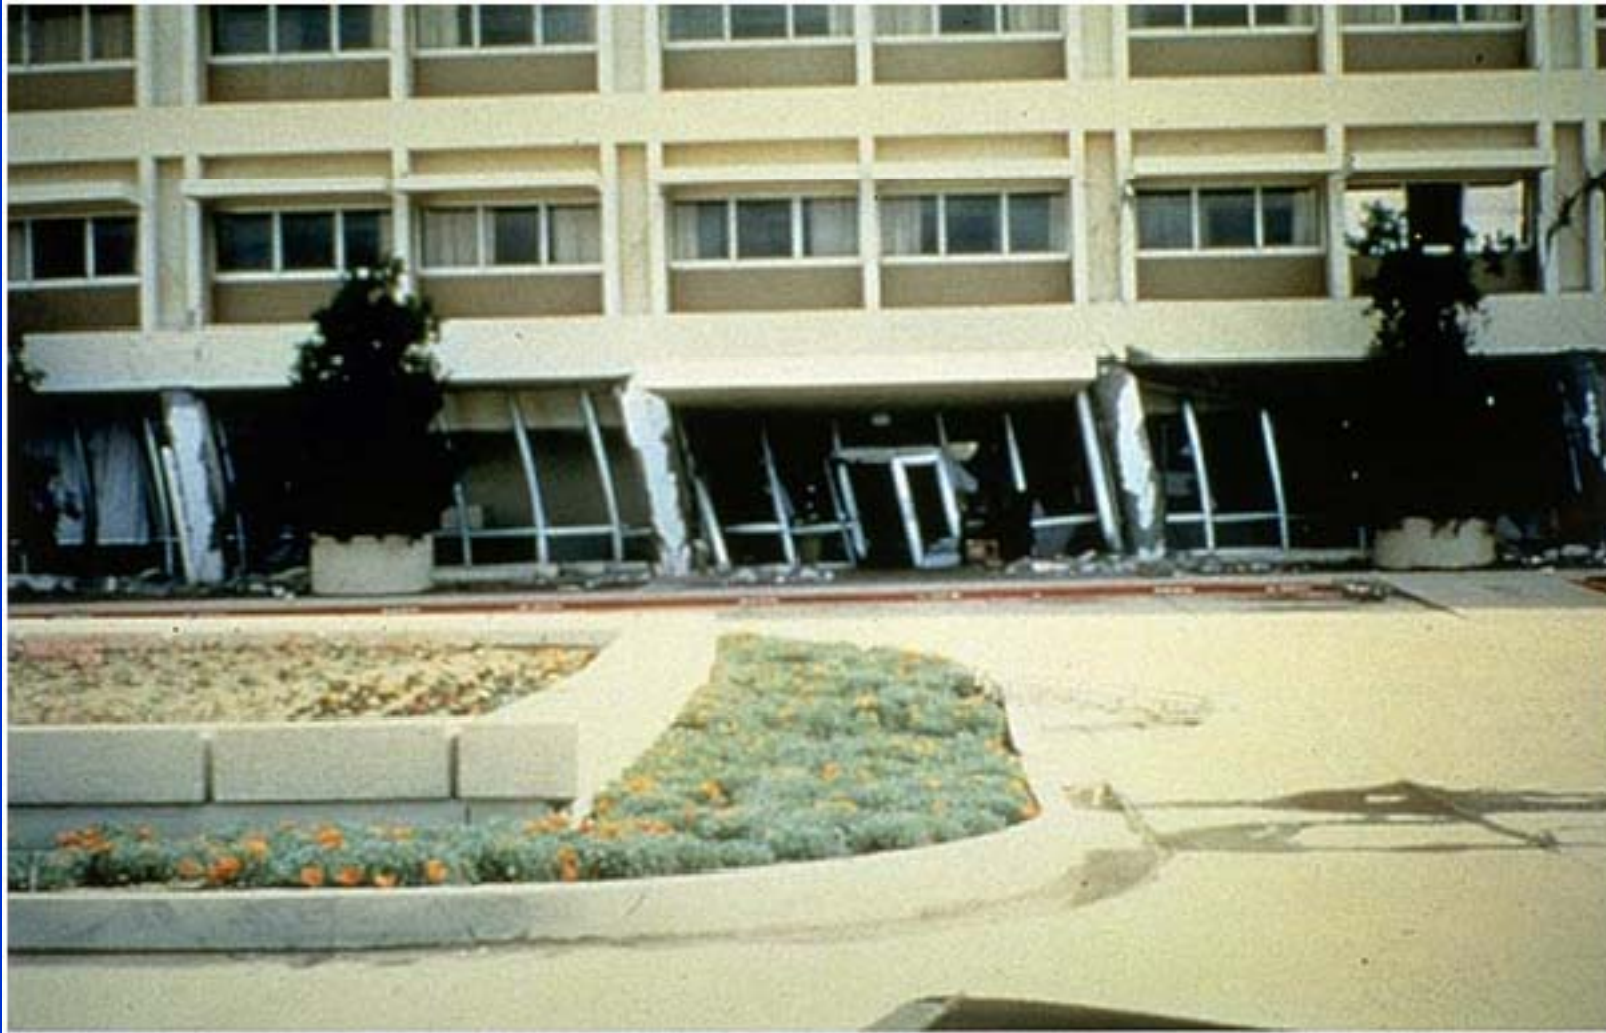
**Olive View Hospital building in ML 6.4 San Fernando earthquake. Poor performance of **SOFT-STORY** system**

- **Olive View Hospital building after the San Fernando earthquake. The building was close to the center of energy release of the ML 6.4 quake. It was above the plane of the thrust fault and received very strong ground shaking having an estimated peak ground acceleration of  $\pm 0.50 g$ . The building, which was essentially a heavy box on slender columns, was not designed to withstand such strong shaking. ( G.W. HOUSNER, P.C. JENNINGS, " Earthquake Design Criteria " , 1982 )**

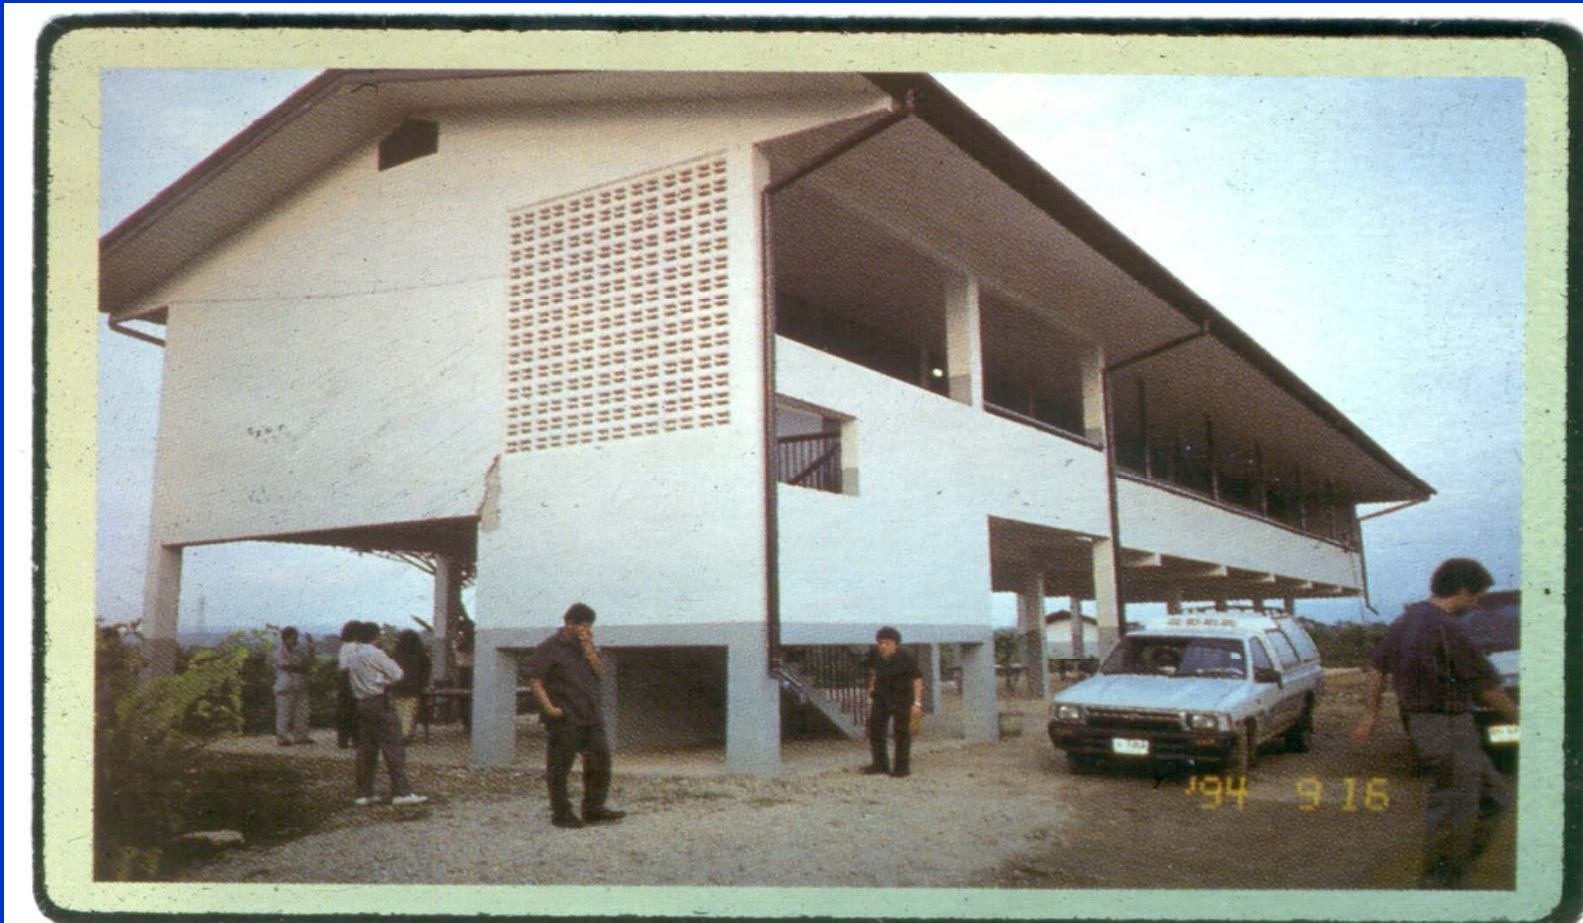
**Damage to a newly built school building in Phan Earthquake, 1994.**

**Note soft-story and torsional irregular system**

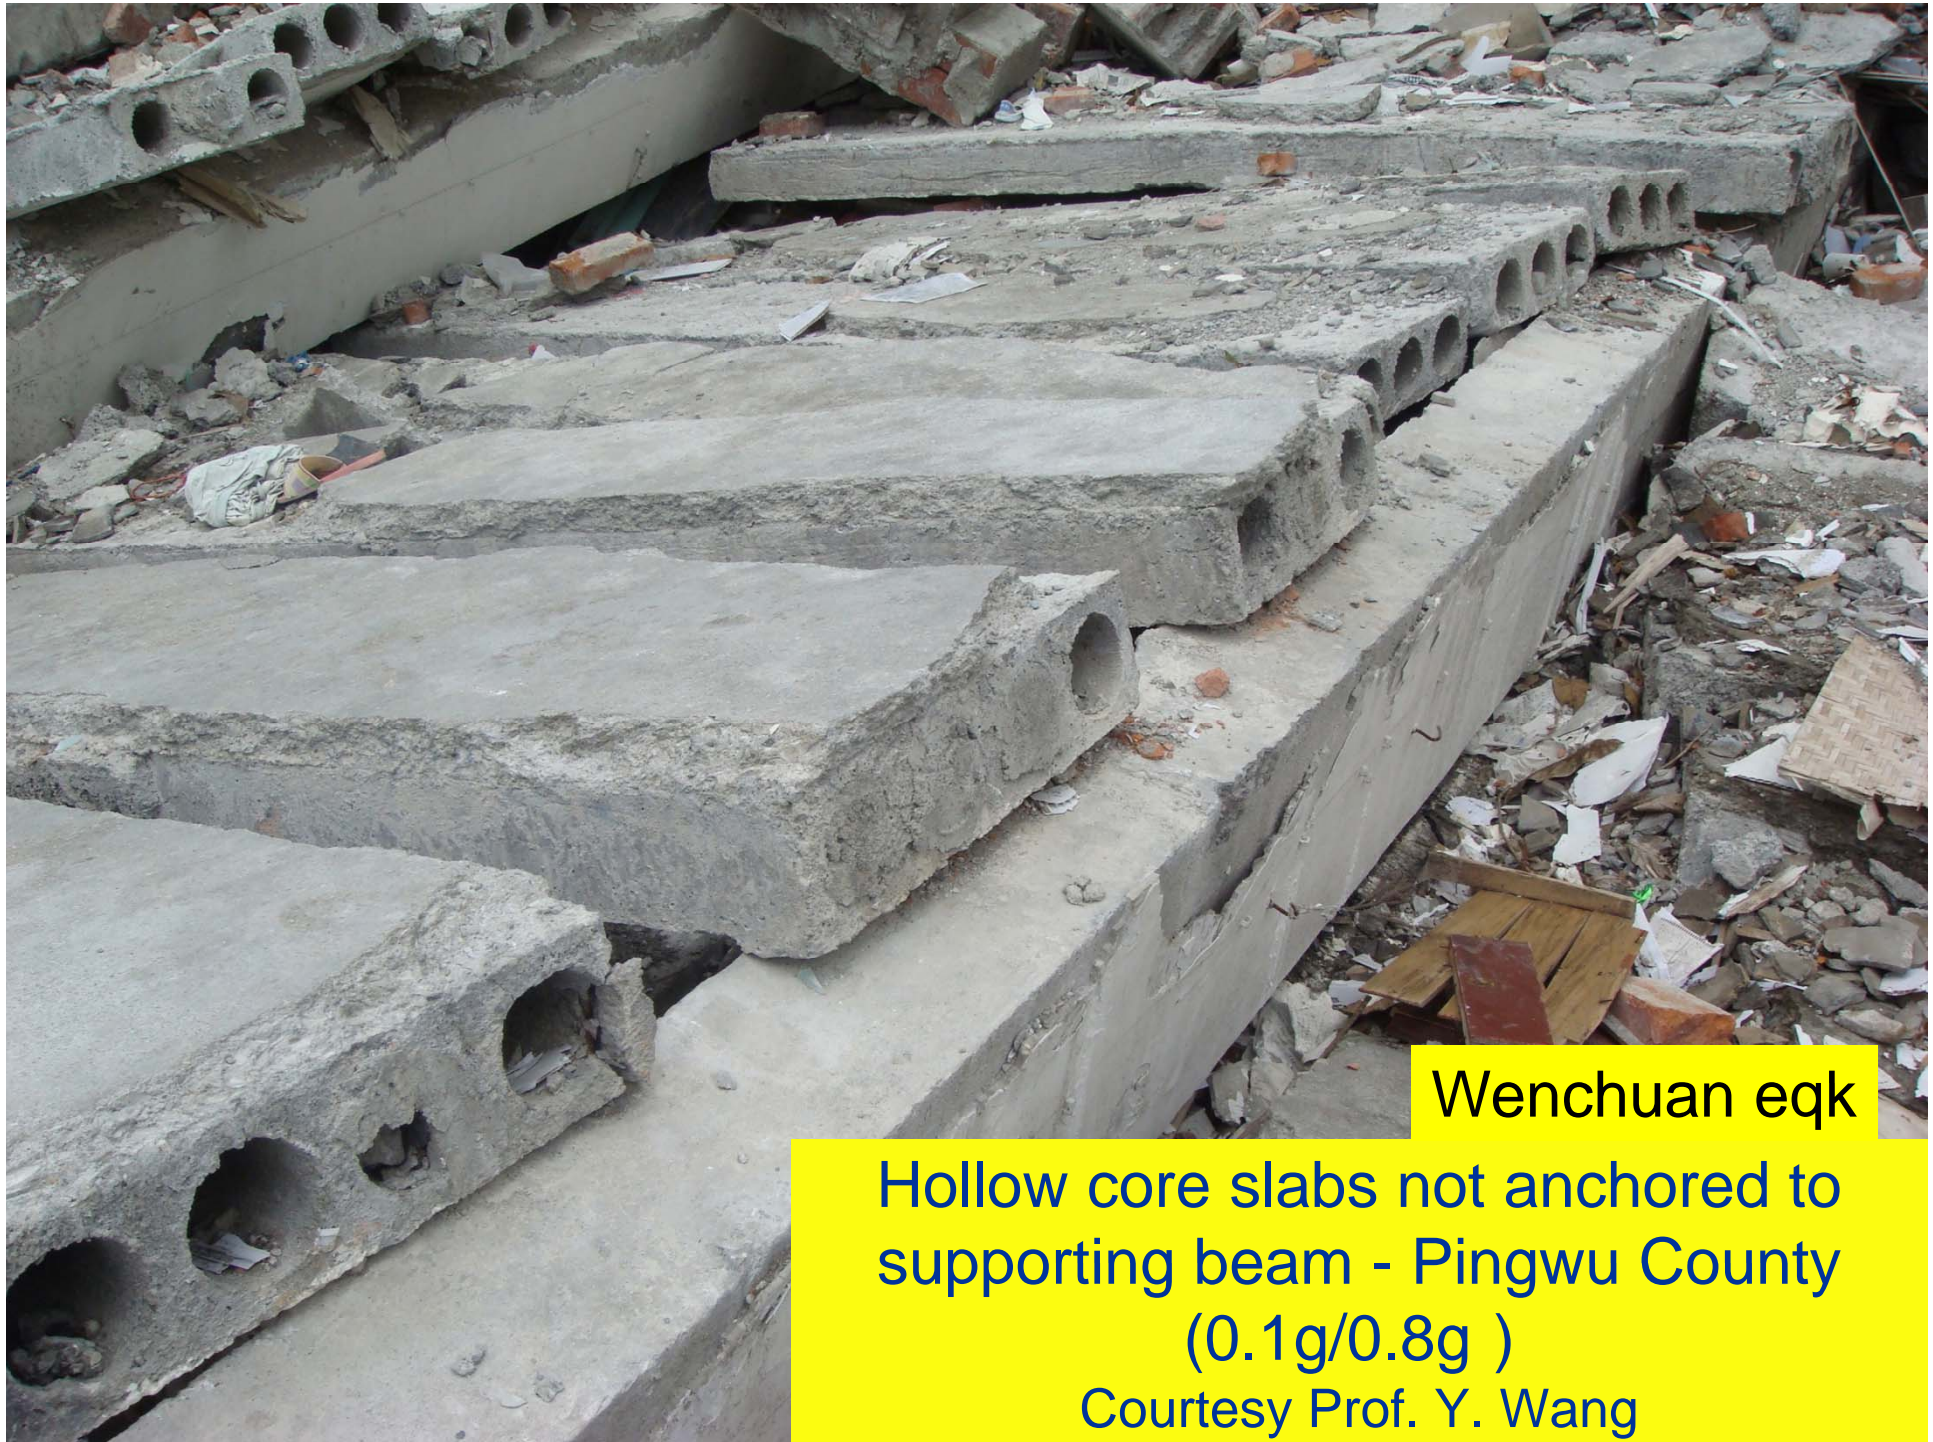
Wenchuan eqk

Hollow core slabs not anchored to supporting beam - Pingwu County (0.1g/0.8g )

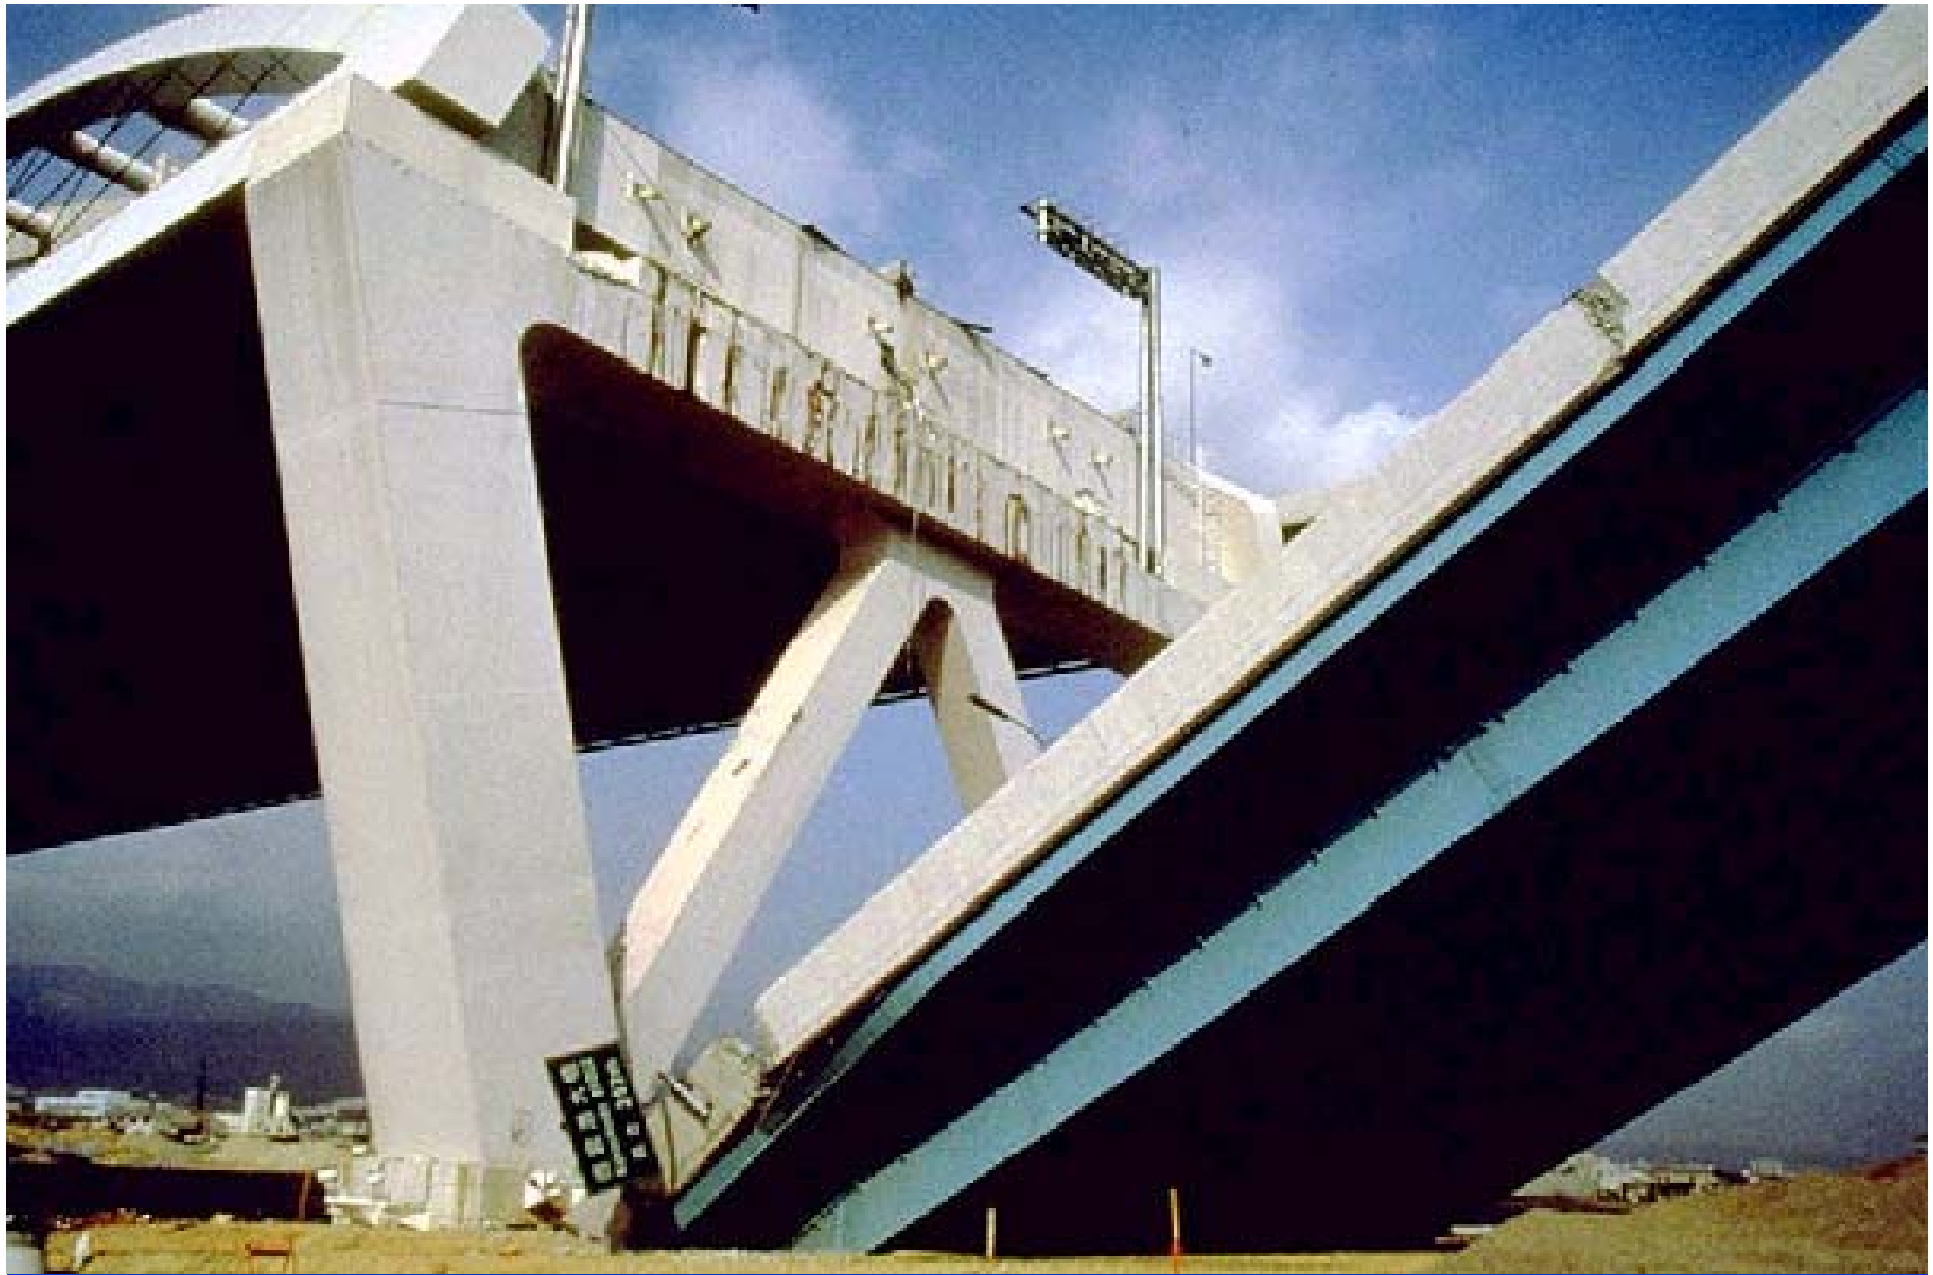
A closer view showing the collapsed span and the arch pier. **Failure caused by loss of support.**

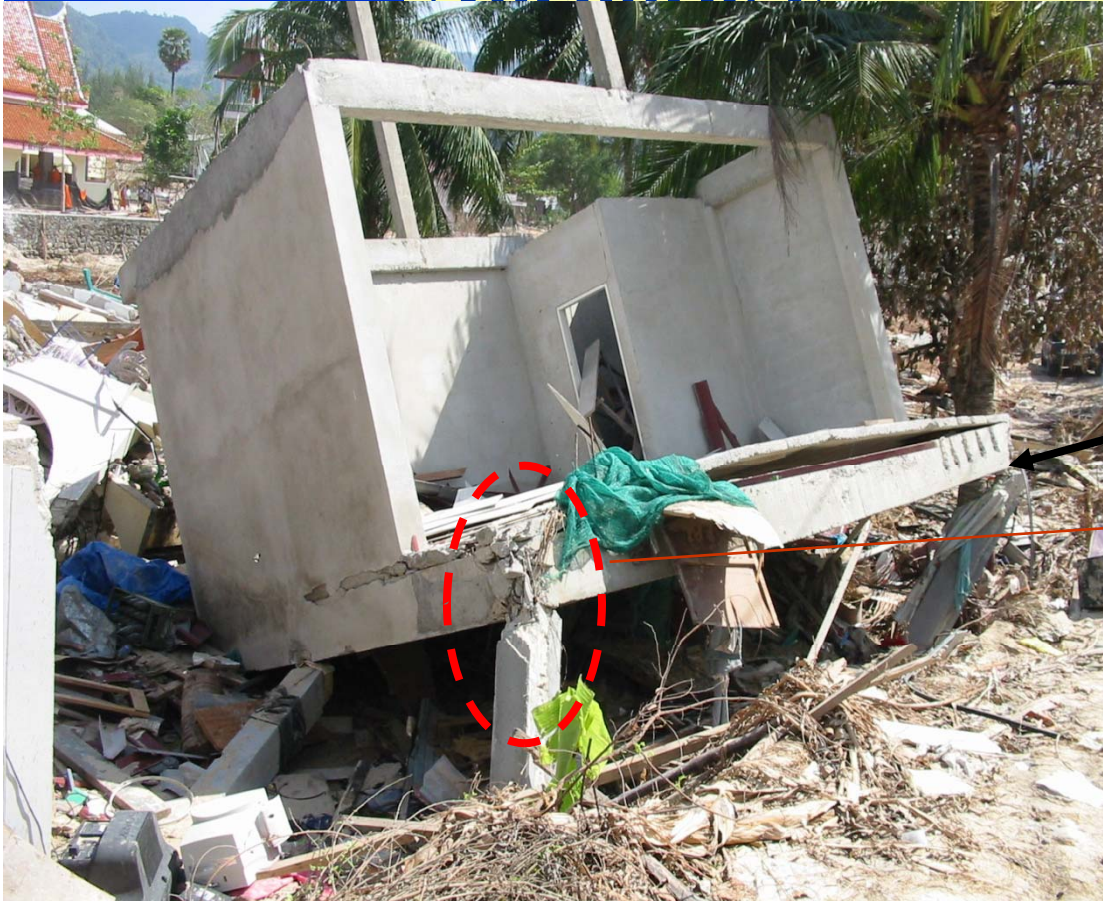
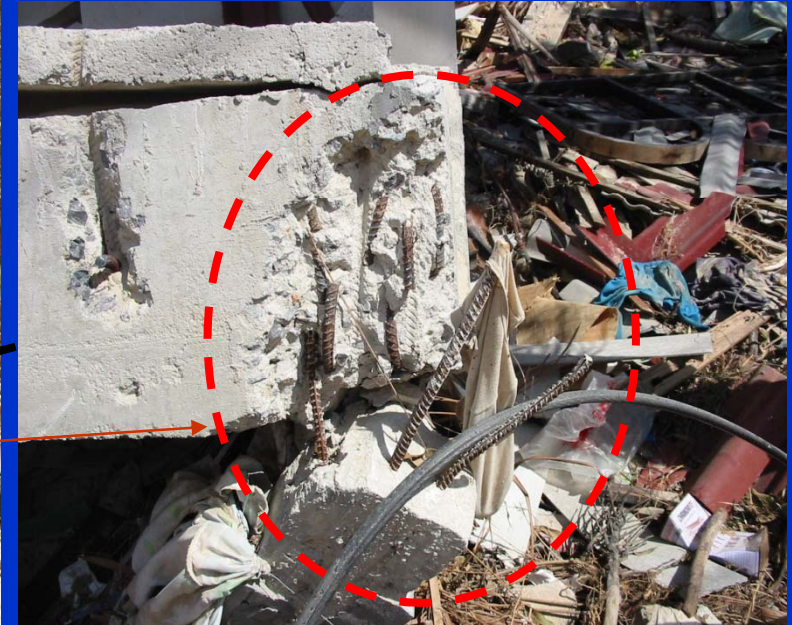
## Failure due to Inadequate Anchorage

คานกับตอม่อยึดกันไม่แข็งแรงพอ และตอม่อเล็กไป (ไม่ได้ล้วงเหล็กคานเข้าไปในตอม่อให้ลึกพอ)

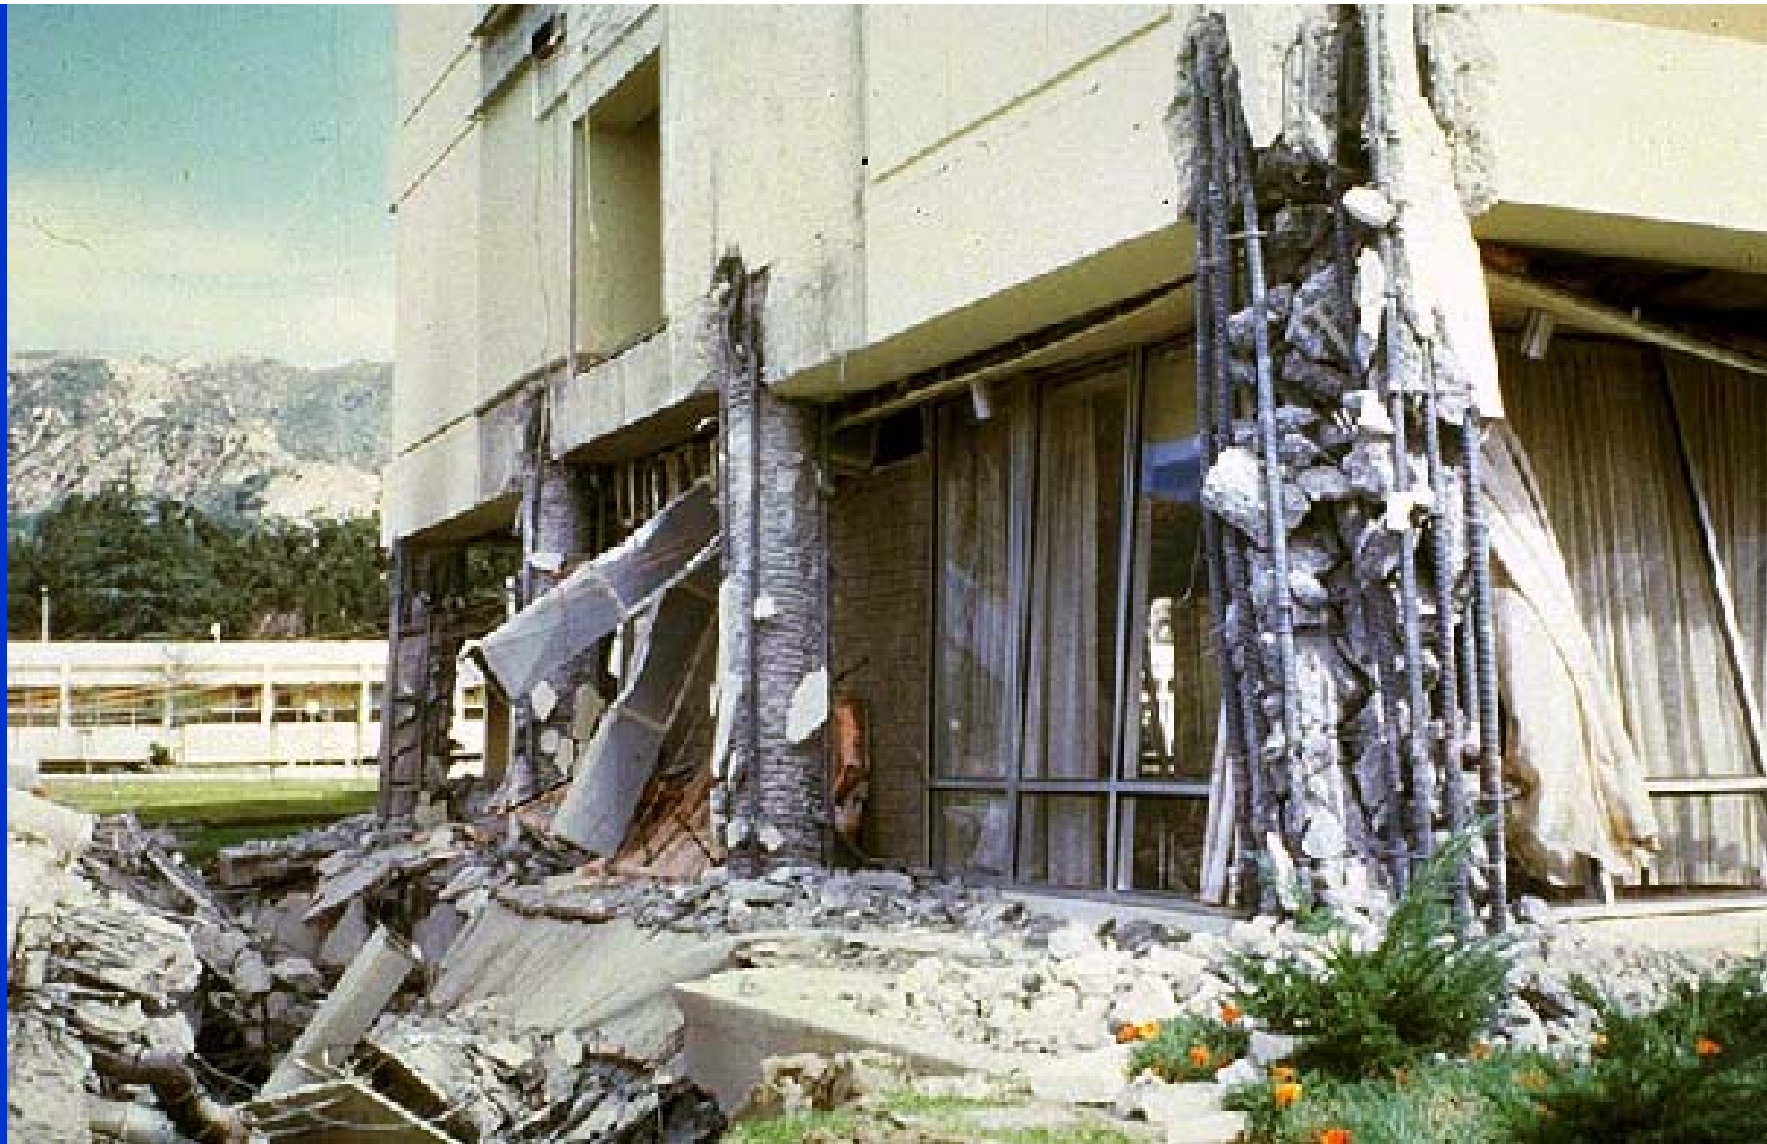
Confinement of  
concrete for

Ductility

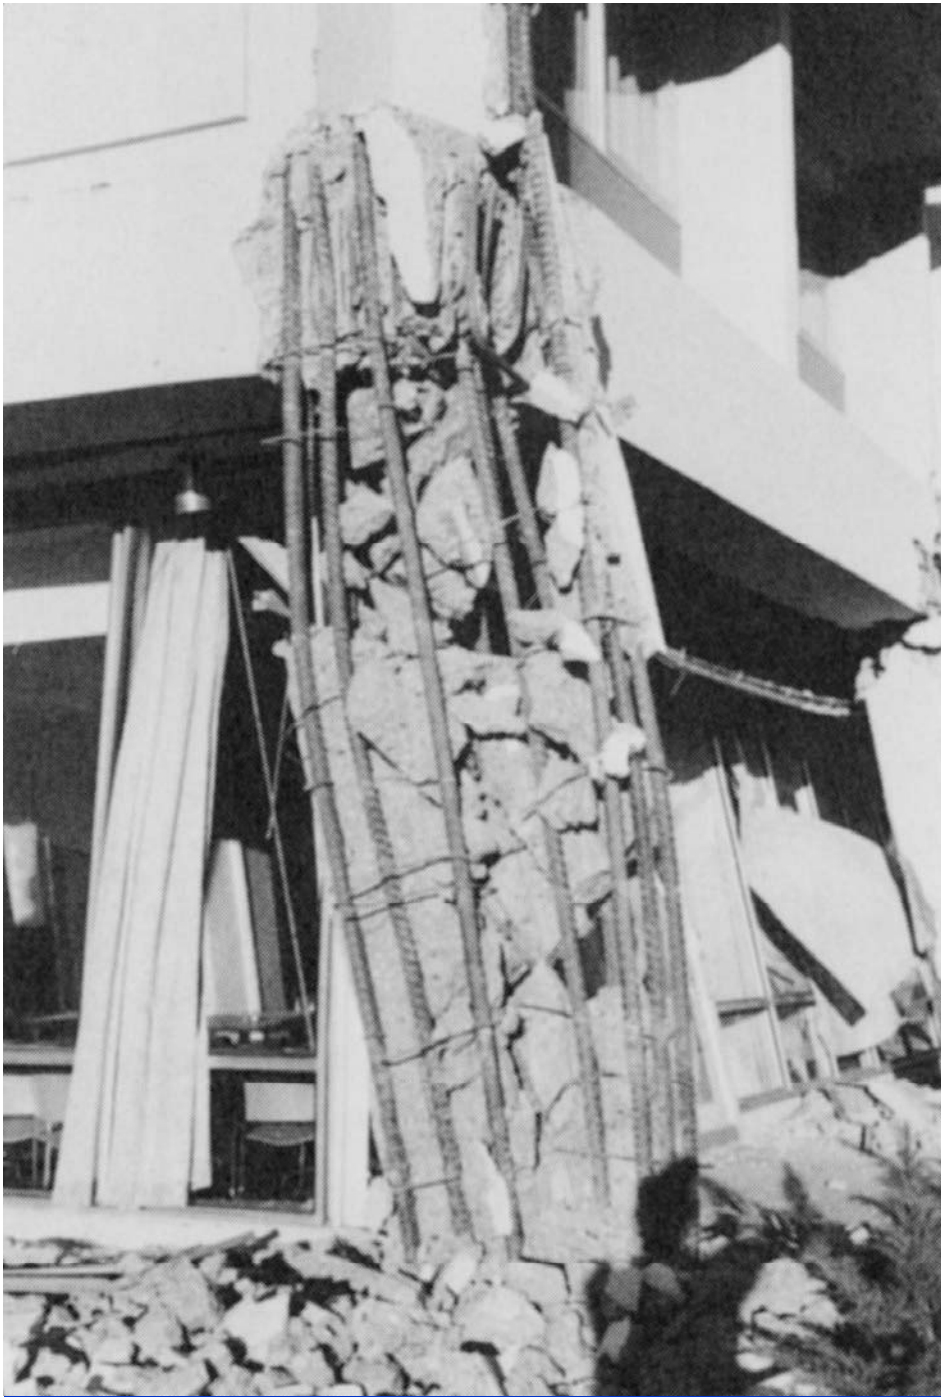
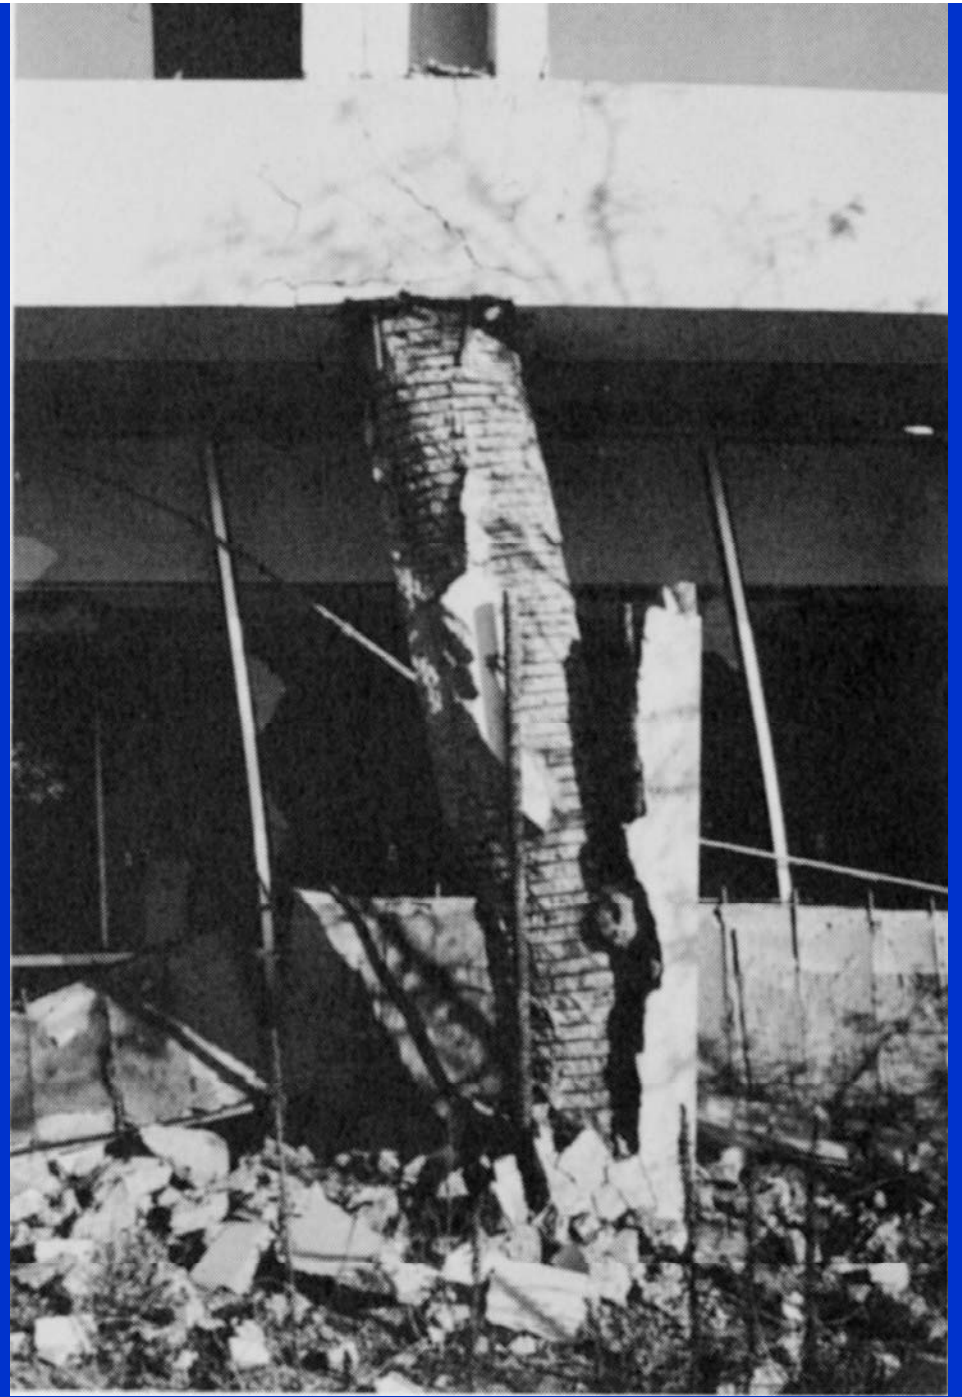
### **Ductile vs. Non-ductile Concrete Construction**

*Time and Location of Slide: 1971, San Fernando, CA* Ductile reinforcing of concrete is a necessity. Note the obvious differences of capability of concrete columns to take load after earthquake damage. The spirally rein-forced column (ductile reinforcing) has an obvious capacity to carry much more load than the tied corner column (non-ductile reinforcing).

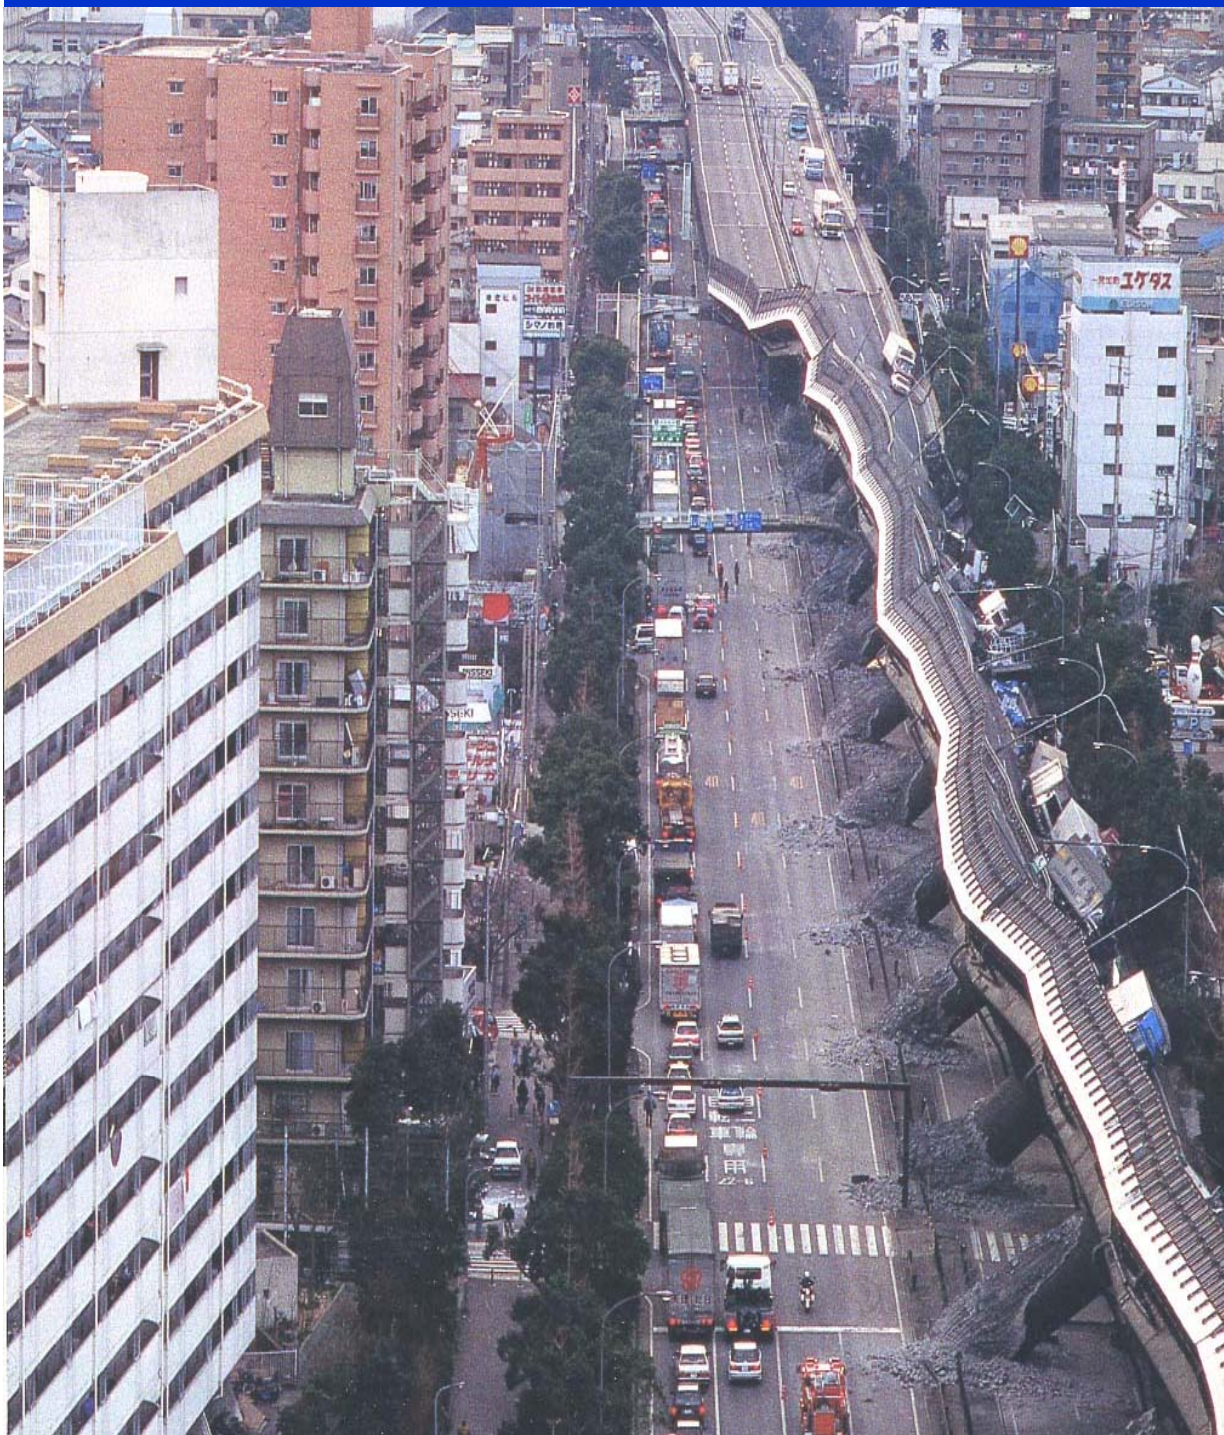
**Shear failure of large  
bridge piers in Kobe  
Earthquake, 1995**

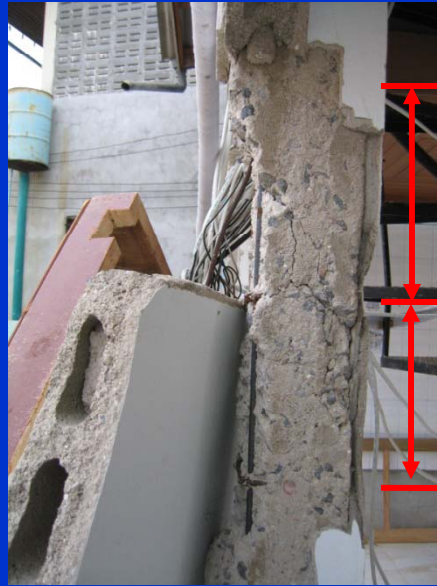
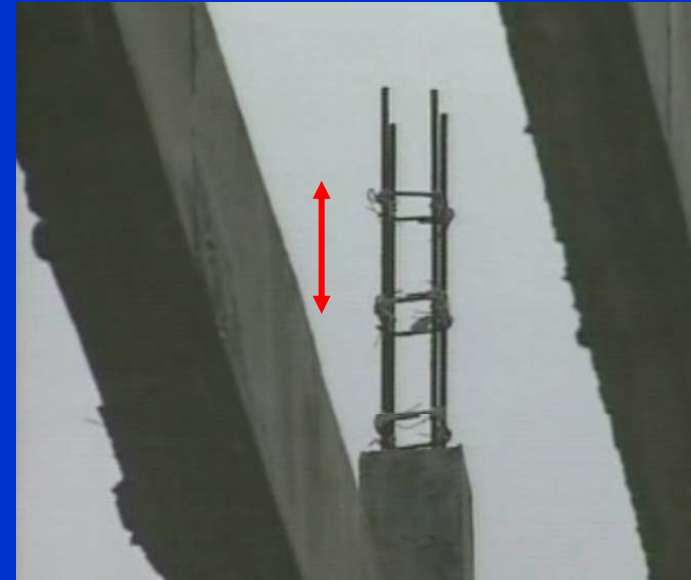
ระยะห่างของเหล็กปลอก (แสดงด้วยลูกศรในรูป) ห่างมากเกินไป

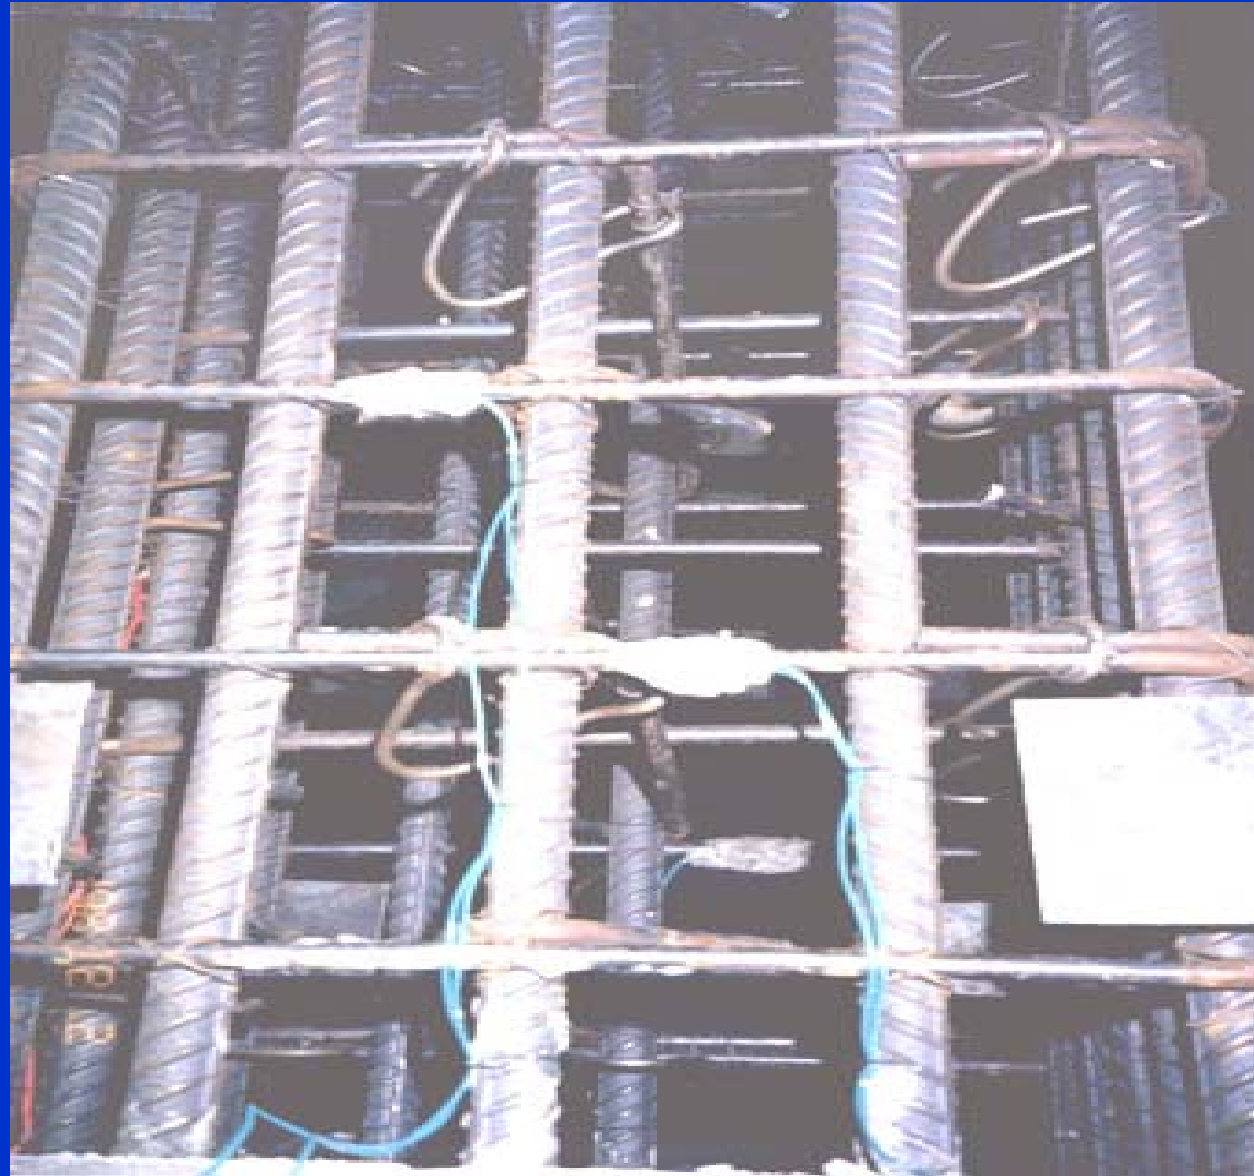
# Improvement of 90-deg hook by HOOK-CLIP

**HOOK-CLIP** - Patented (but released now)

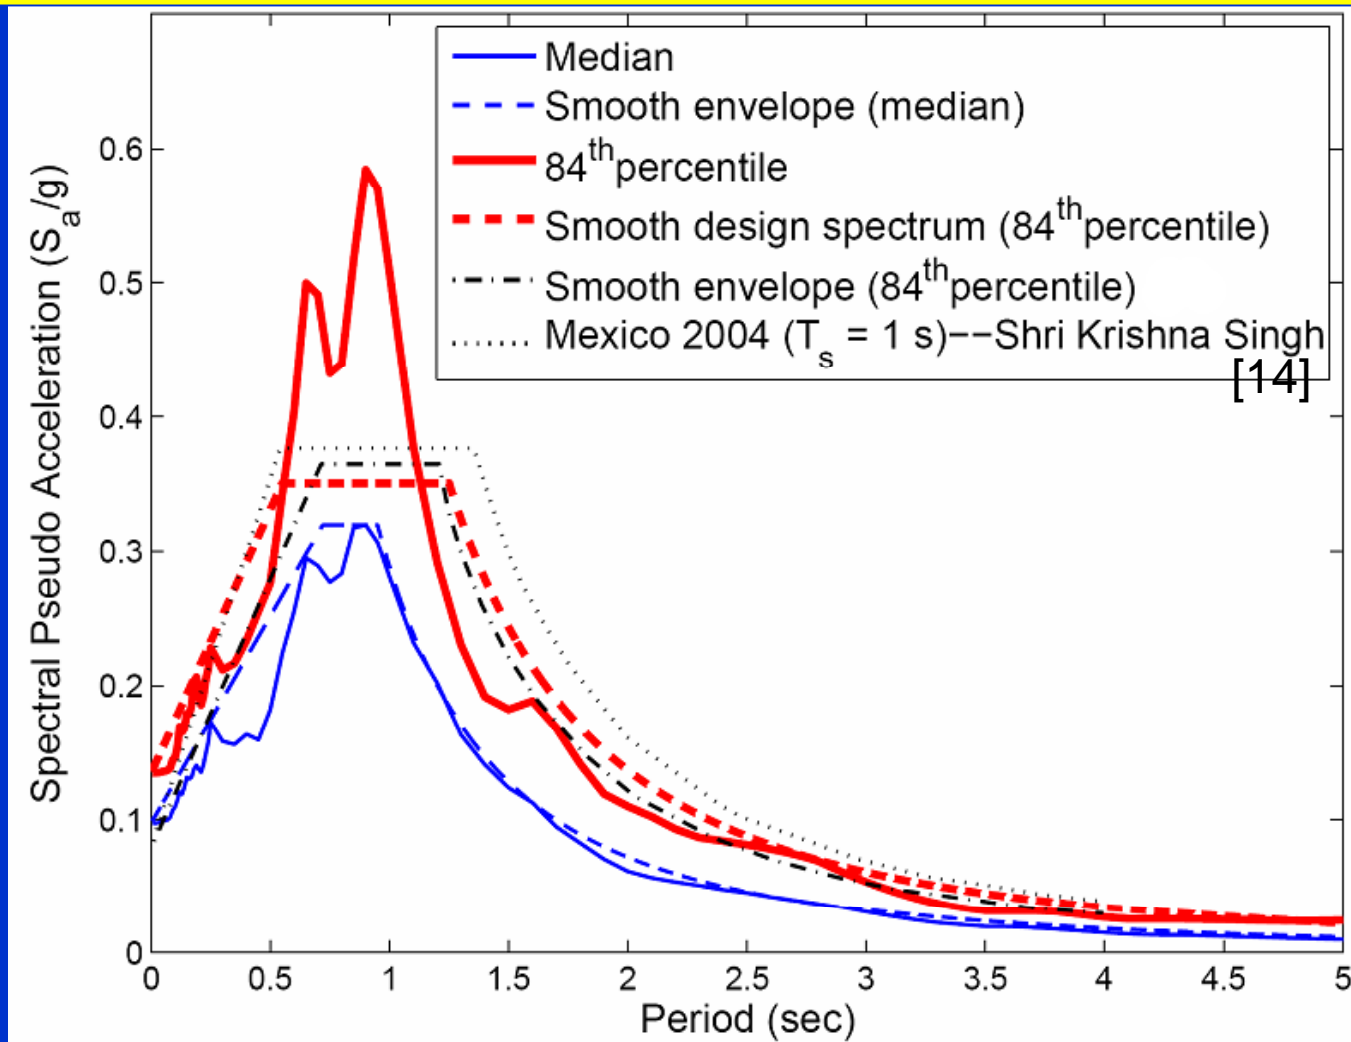
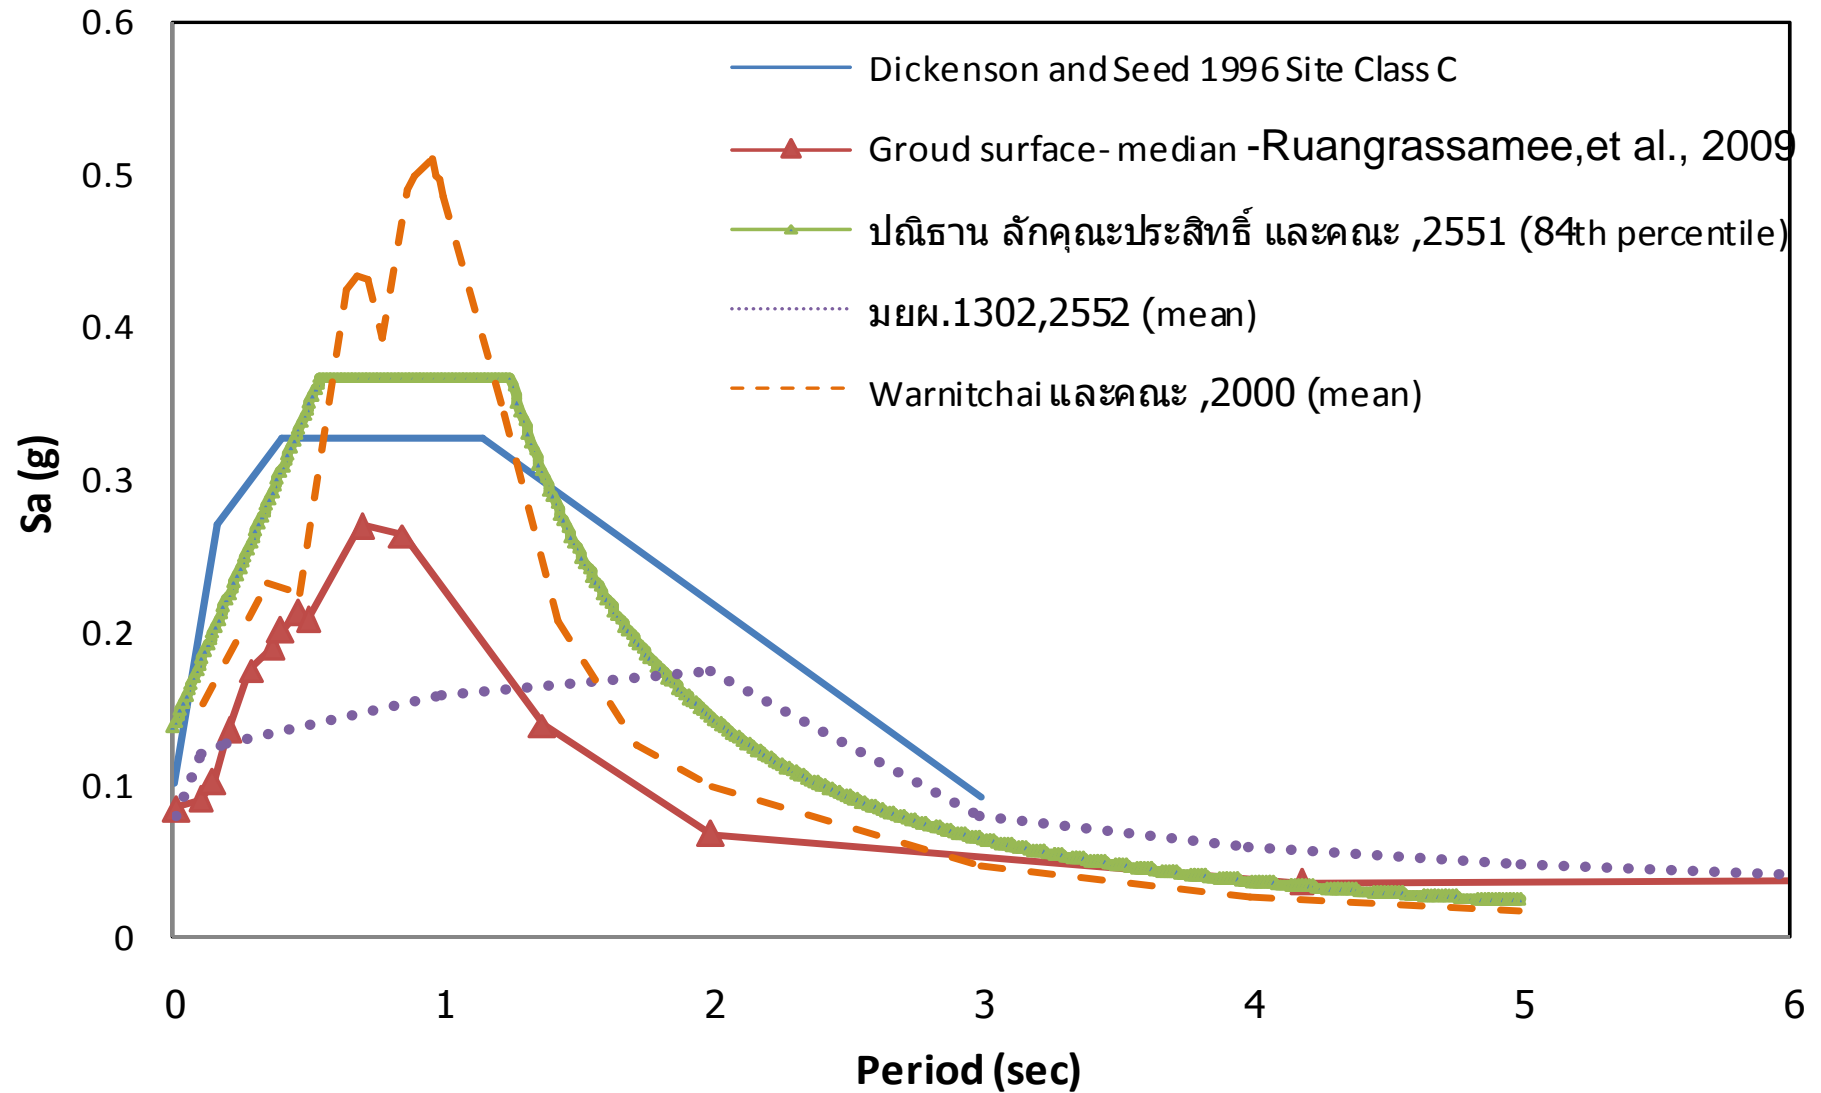
## Elastic response spectra for Bangkok soil site (PRA=0.03g)

Elastic response spectra for Bangkok soil site (PRA=0.03g, 5% damping ratio)
