Avoid irregular and  
discontinuous systems

# ตัวอย่างความไม่ต่อเนื่องของโครงสร้างในแนวดิ่ง (จาก มยพ.1301-50 กรมโยธาธิการและผังเมือง)

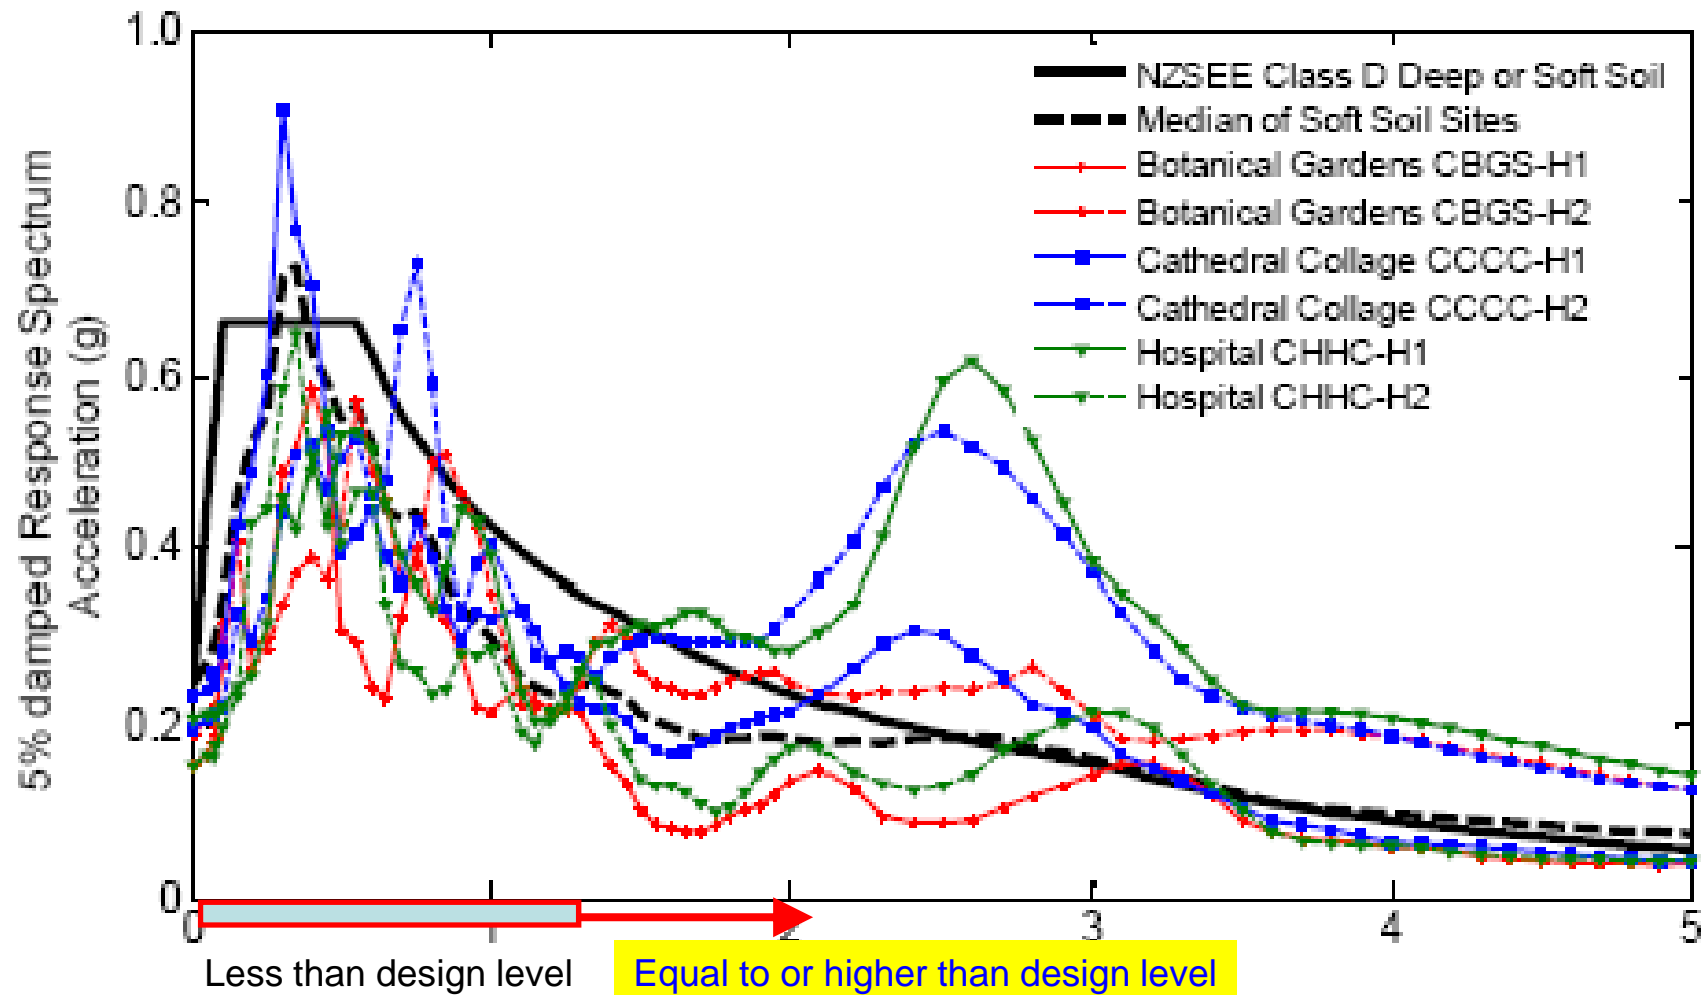
# Comparison with Design Demand, New Zealand earthquake, 2010

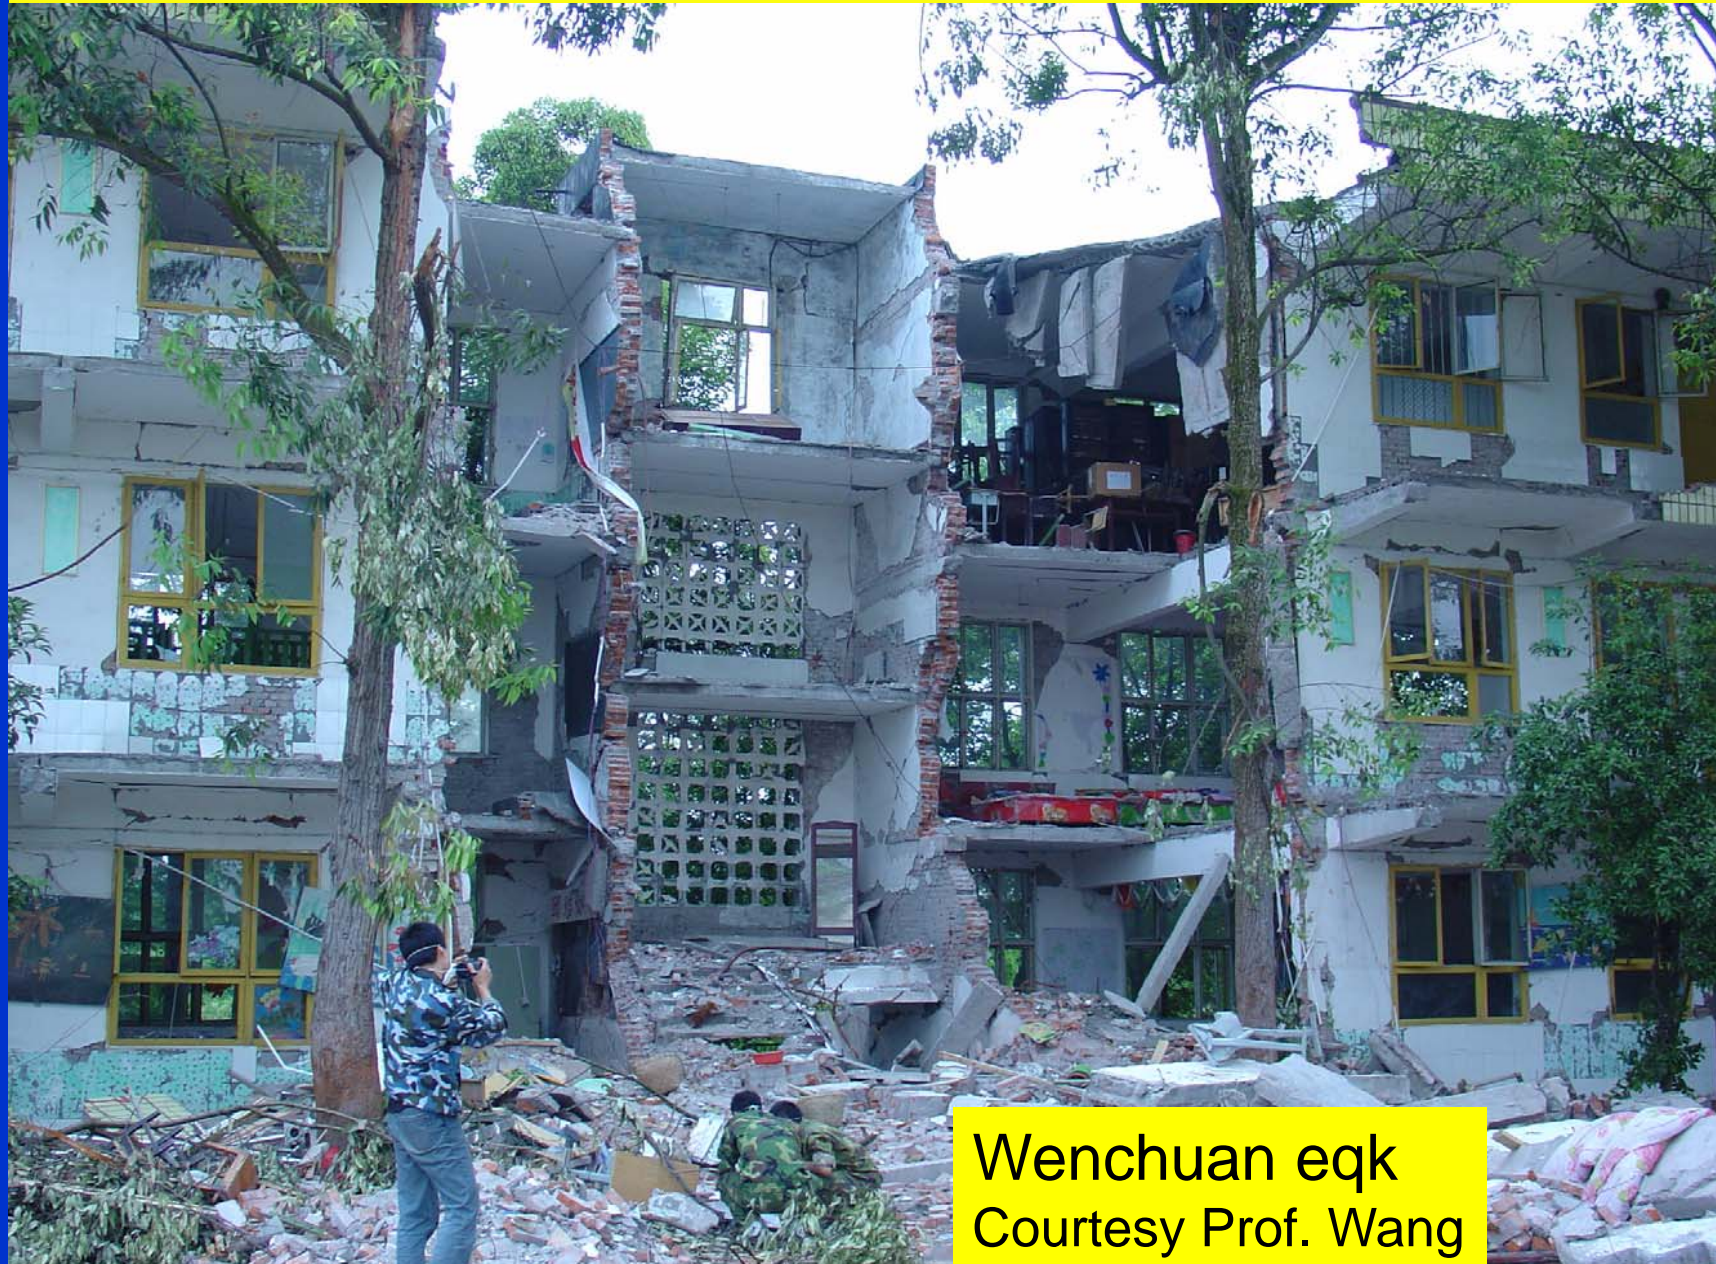
Collapsed stair shaft in middle of a school building of masonry structure in Mianzhu City ( 0.1g/0.3g )
