Seismic resistant design overview

Panitan Lukkunaprasit

Center of Excellence in Earthquake

Chulalongkorn University

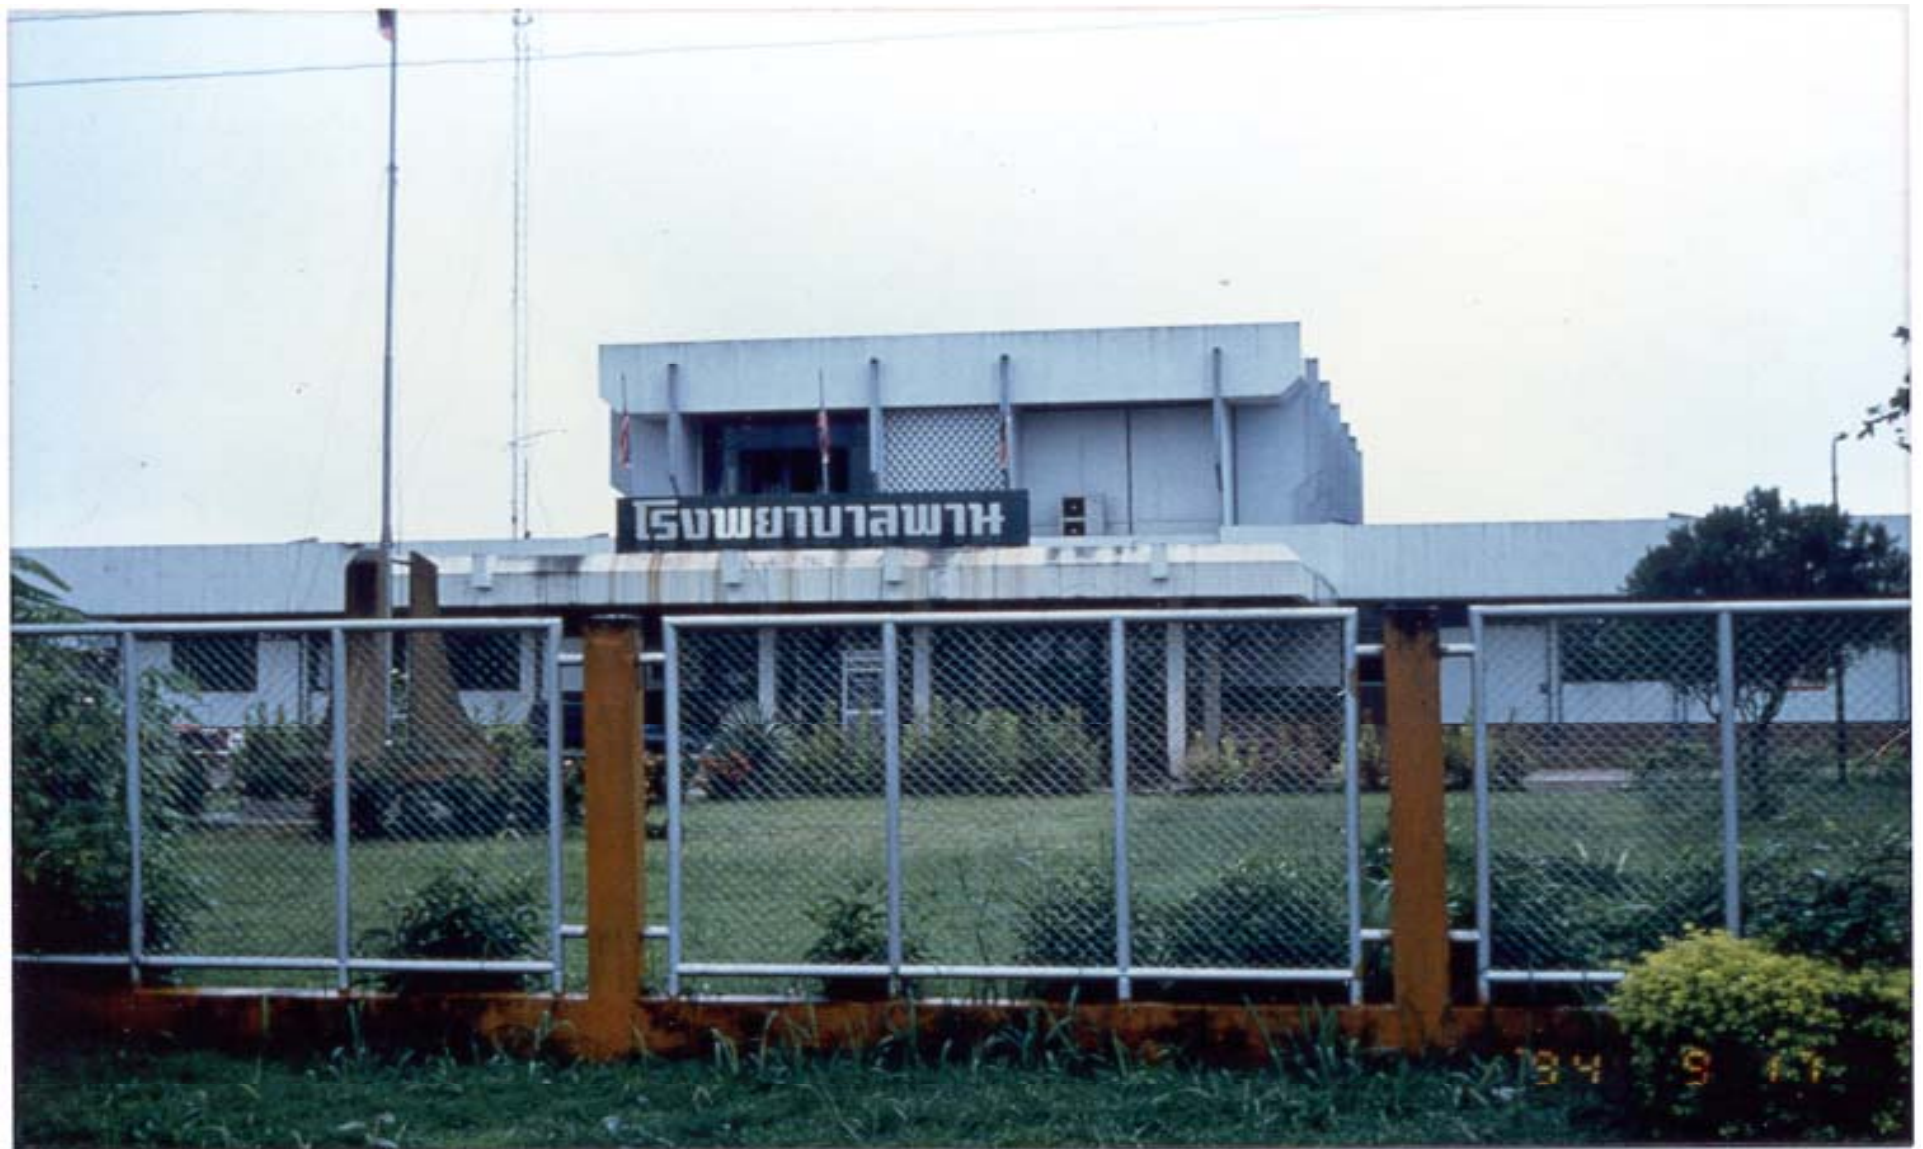
Damage to OPD RC bldg. in Phan Earthquake (Chiangrai)

Sept.1994 M 5.1 Richter R~25 km

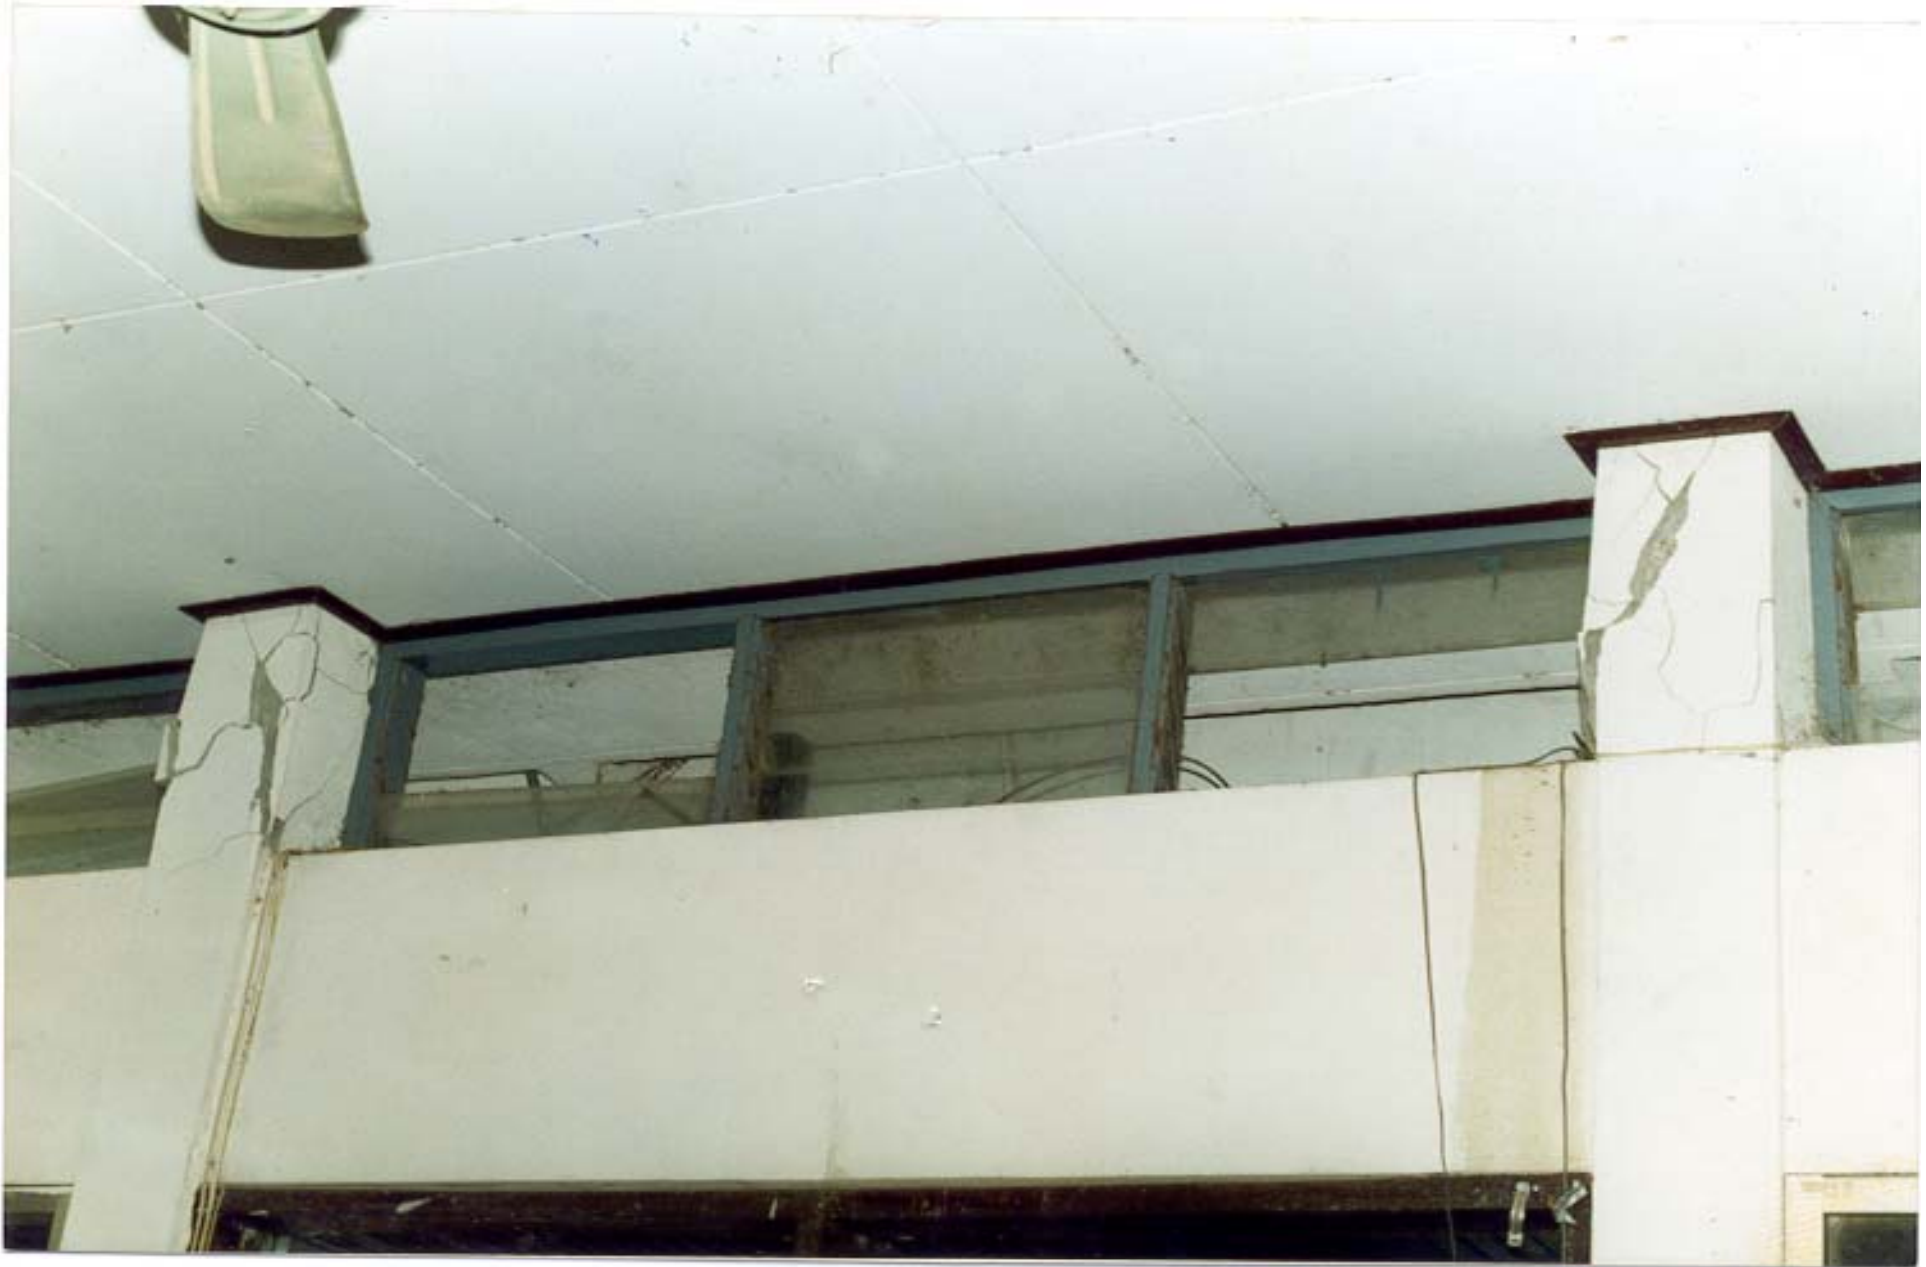
Shear failure in short columns observed even in moderate earthquake

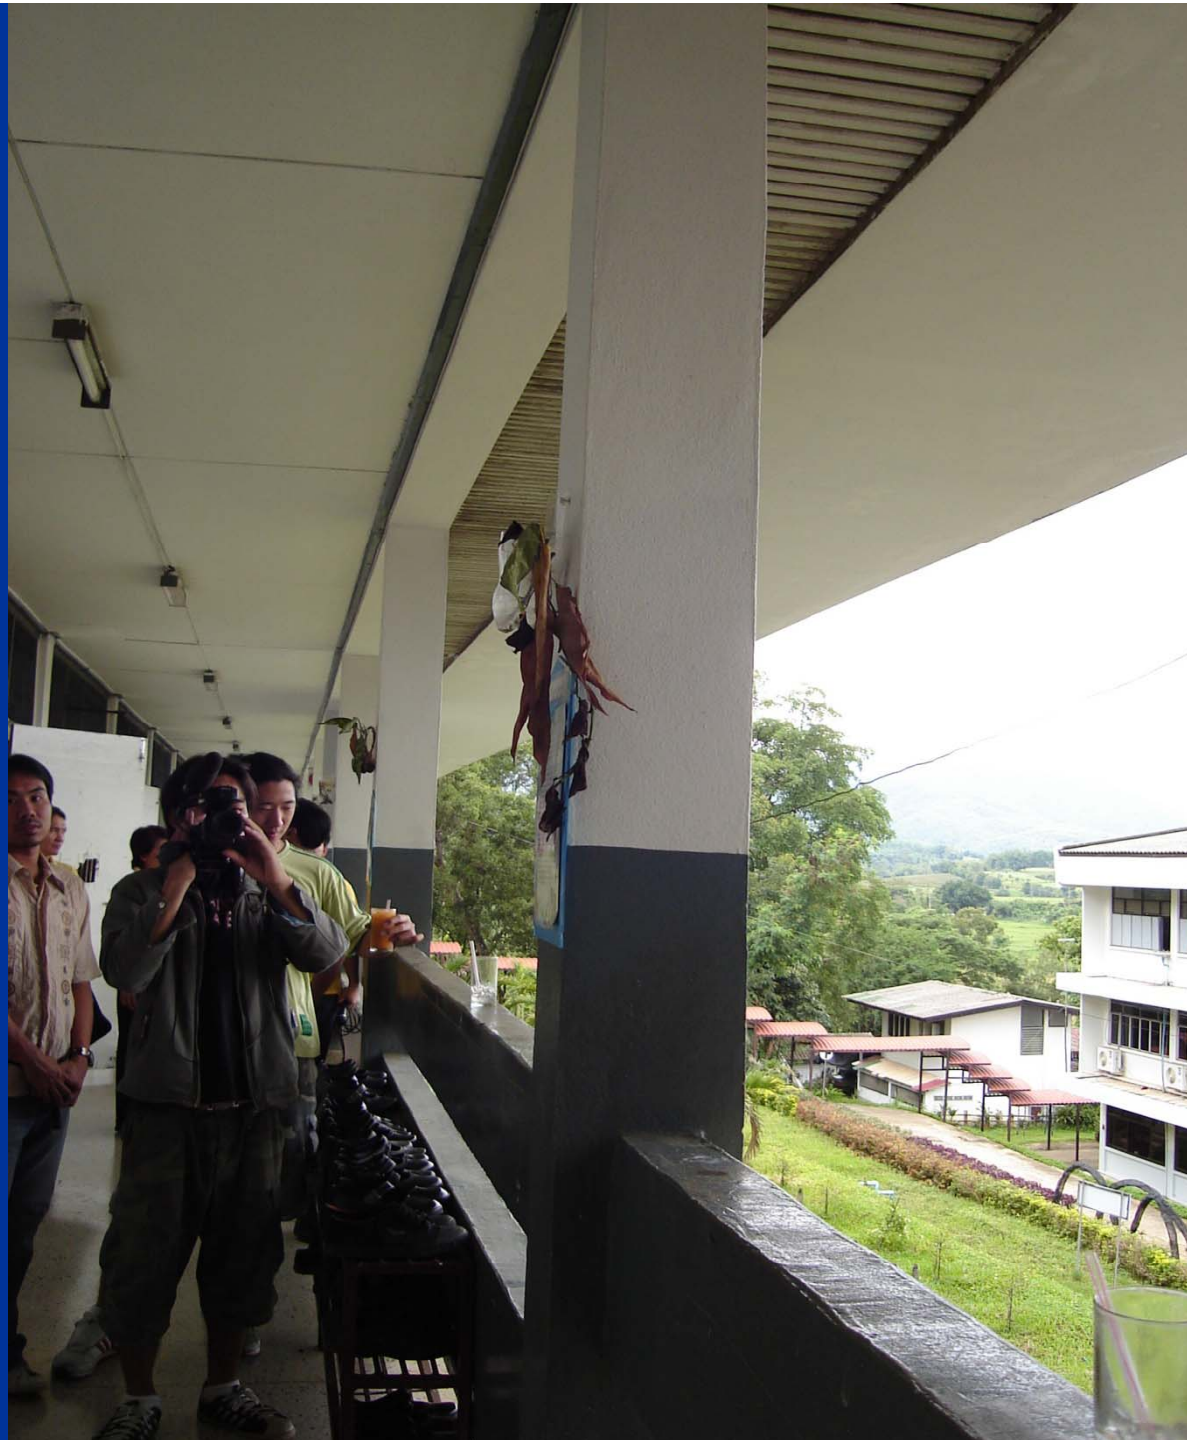
**No damage
to longer
columns**

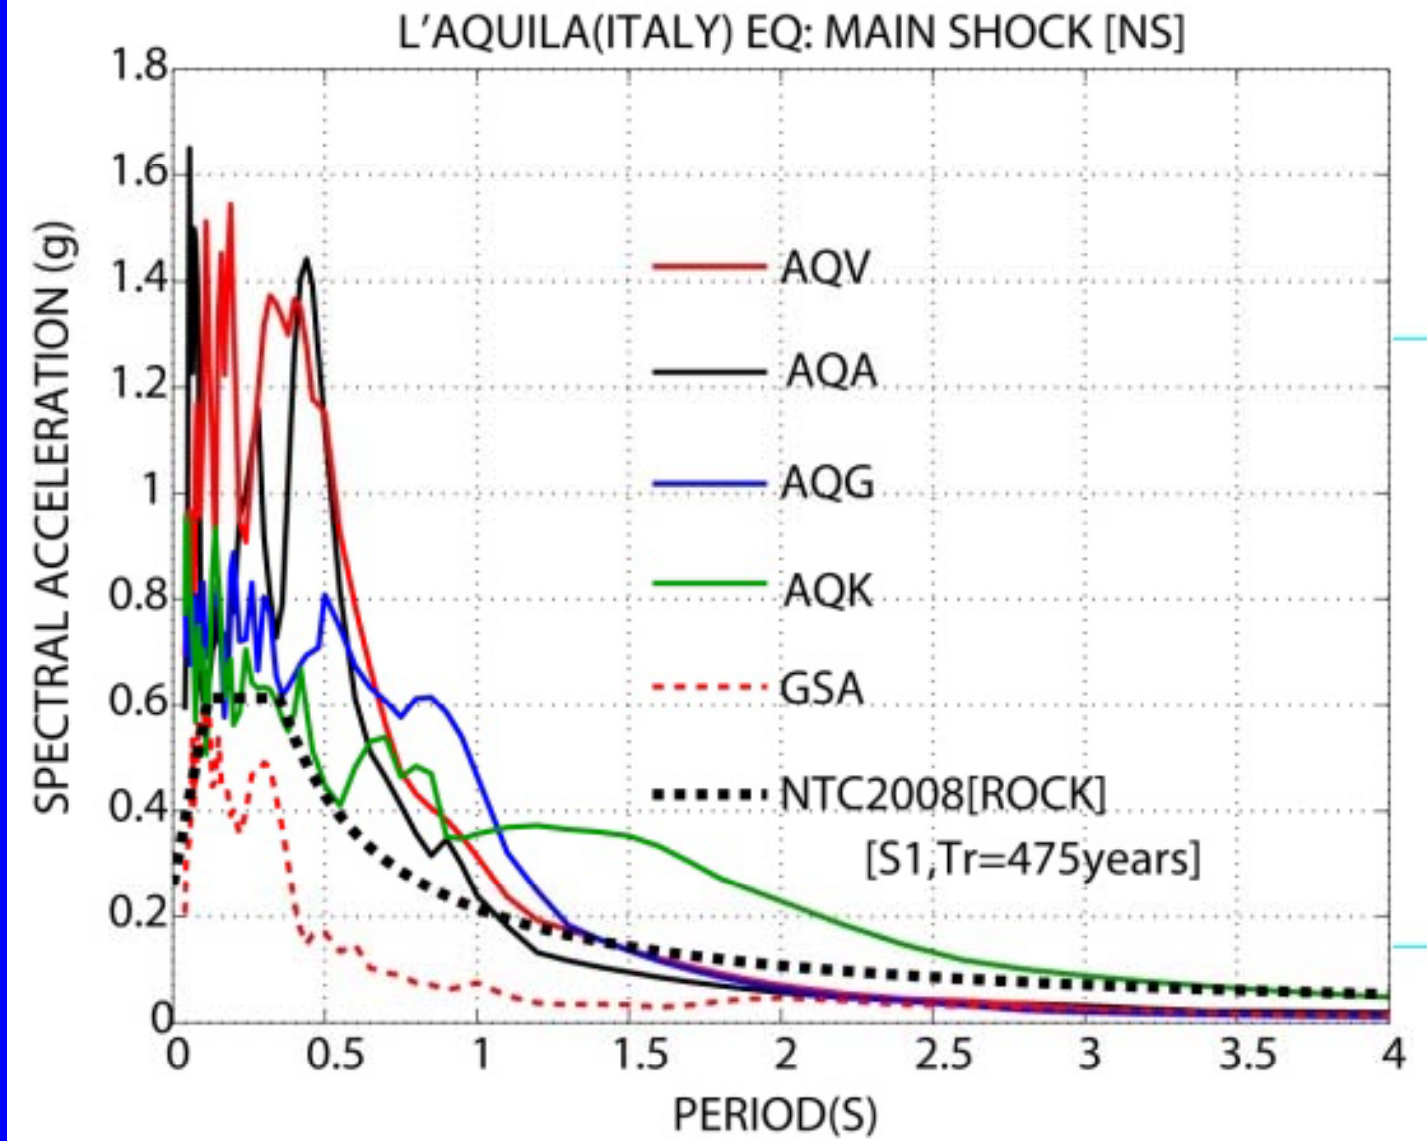
Response spectra for 5% damping and comparison with 2008 Italian Code Spectrum.

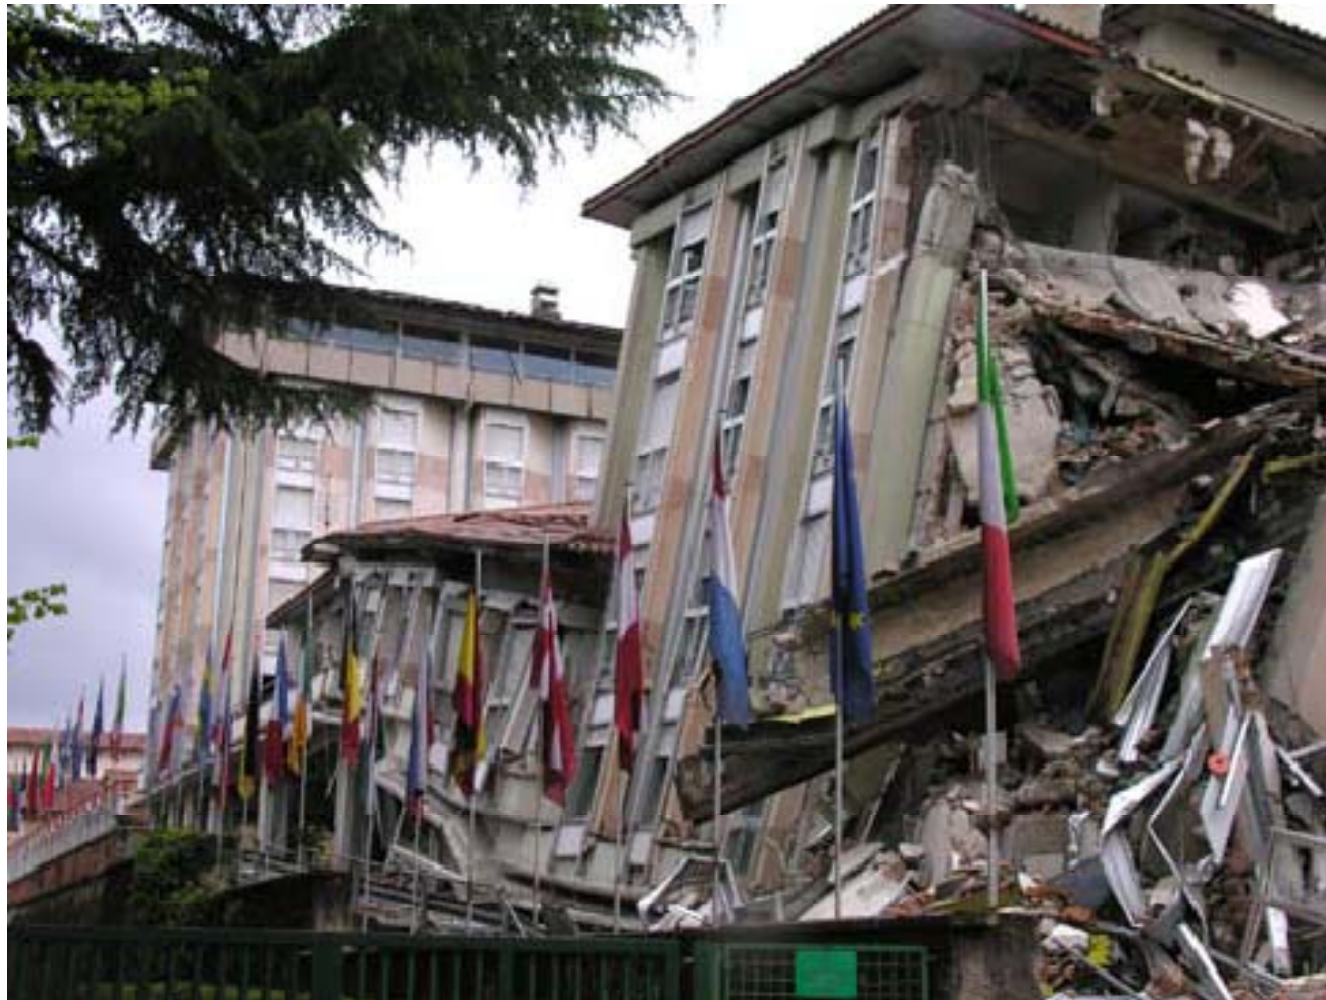
Soft story irregularity

Figure 12. Collapse of part of the Duca D'Abruzzi Hotel caused by a softstory mechanism. The far part of the building was saved by a seismic separation joint.

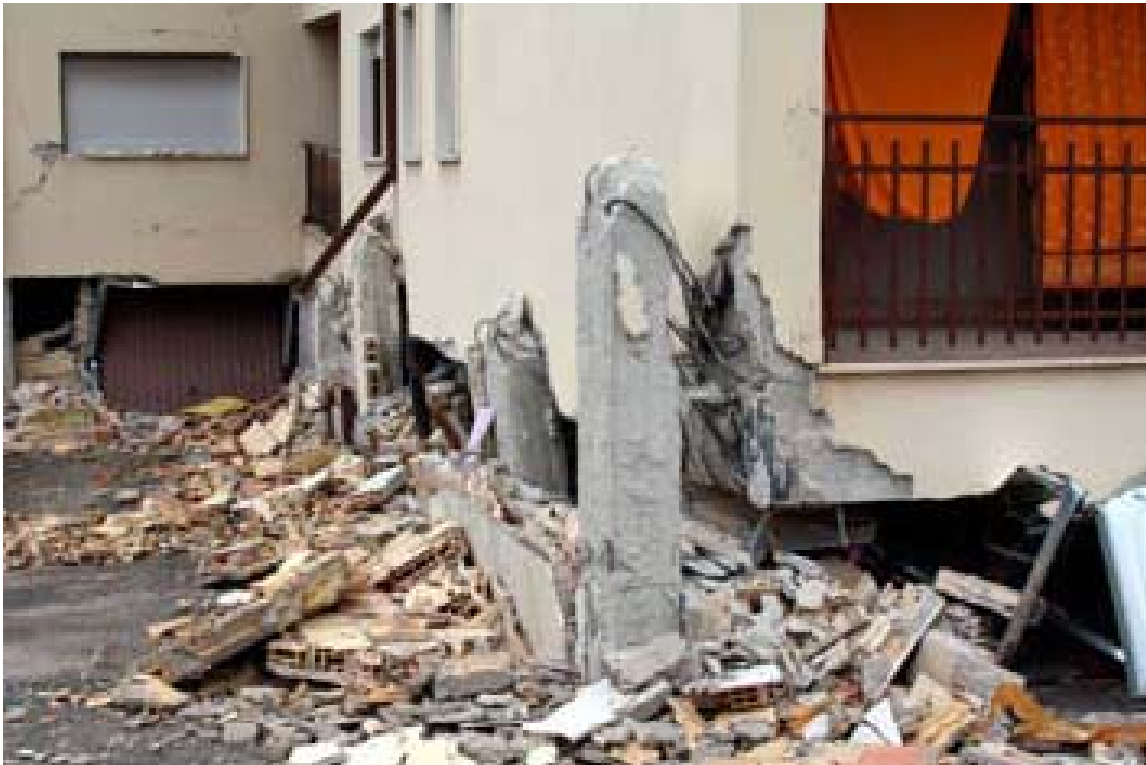
- *Soft-story collapse*
- *Non-ductile detailing*

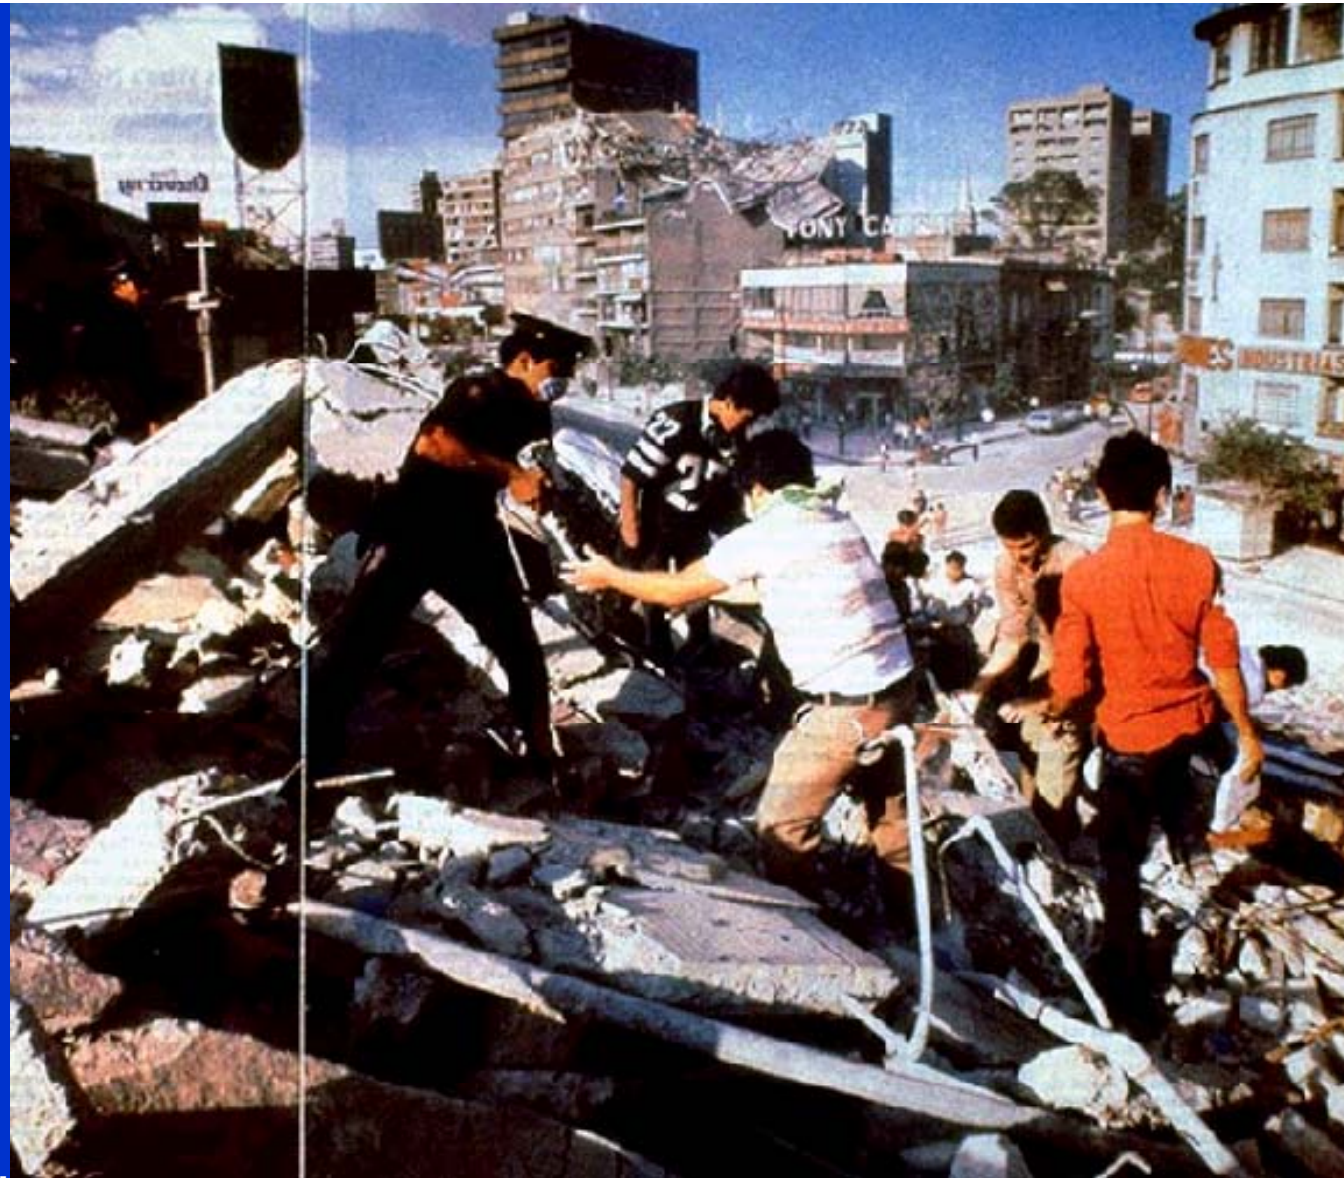
This slide of Mexico City shows damaged and undamaged buildings in the background and a collapsed building in the foreground, the result of the September 19, 1985 Mexico earthquake. Damage was restricted primarily to the lake bed zone which amplified the foundation ground motion and caused the actual demand to exceed the capacity incorporated in the design process.

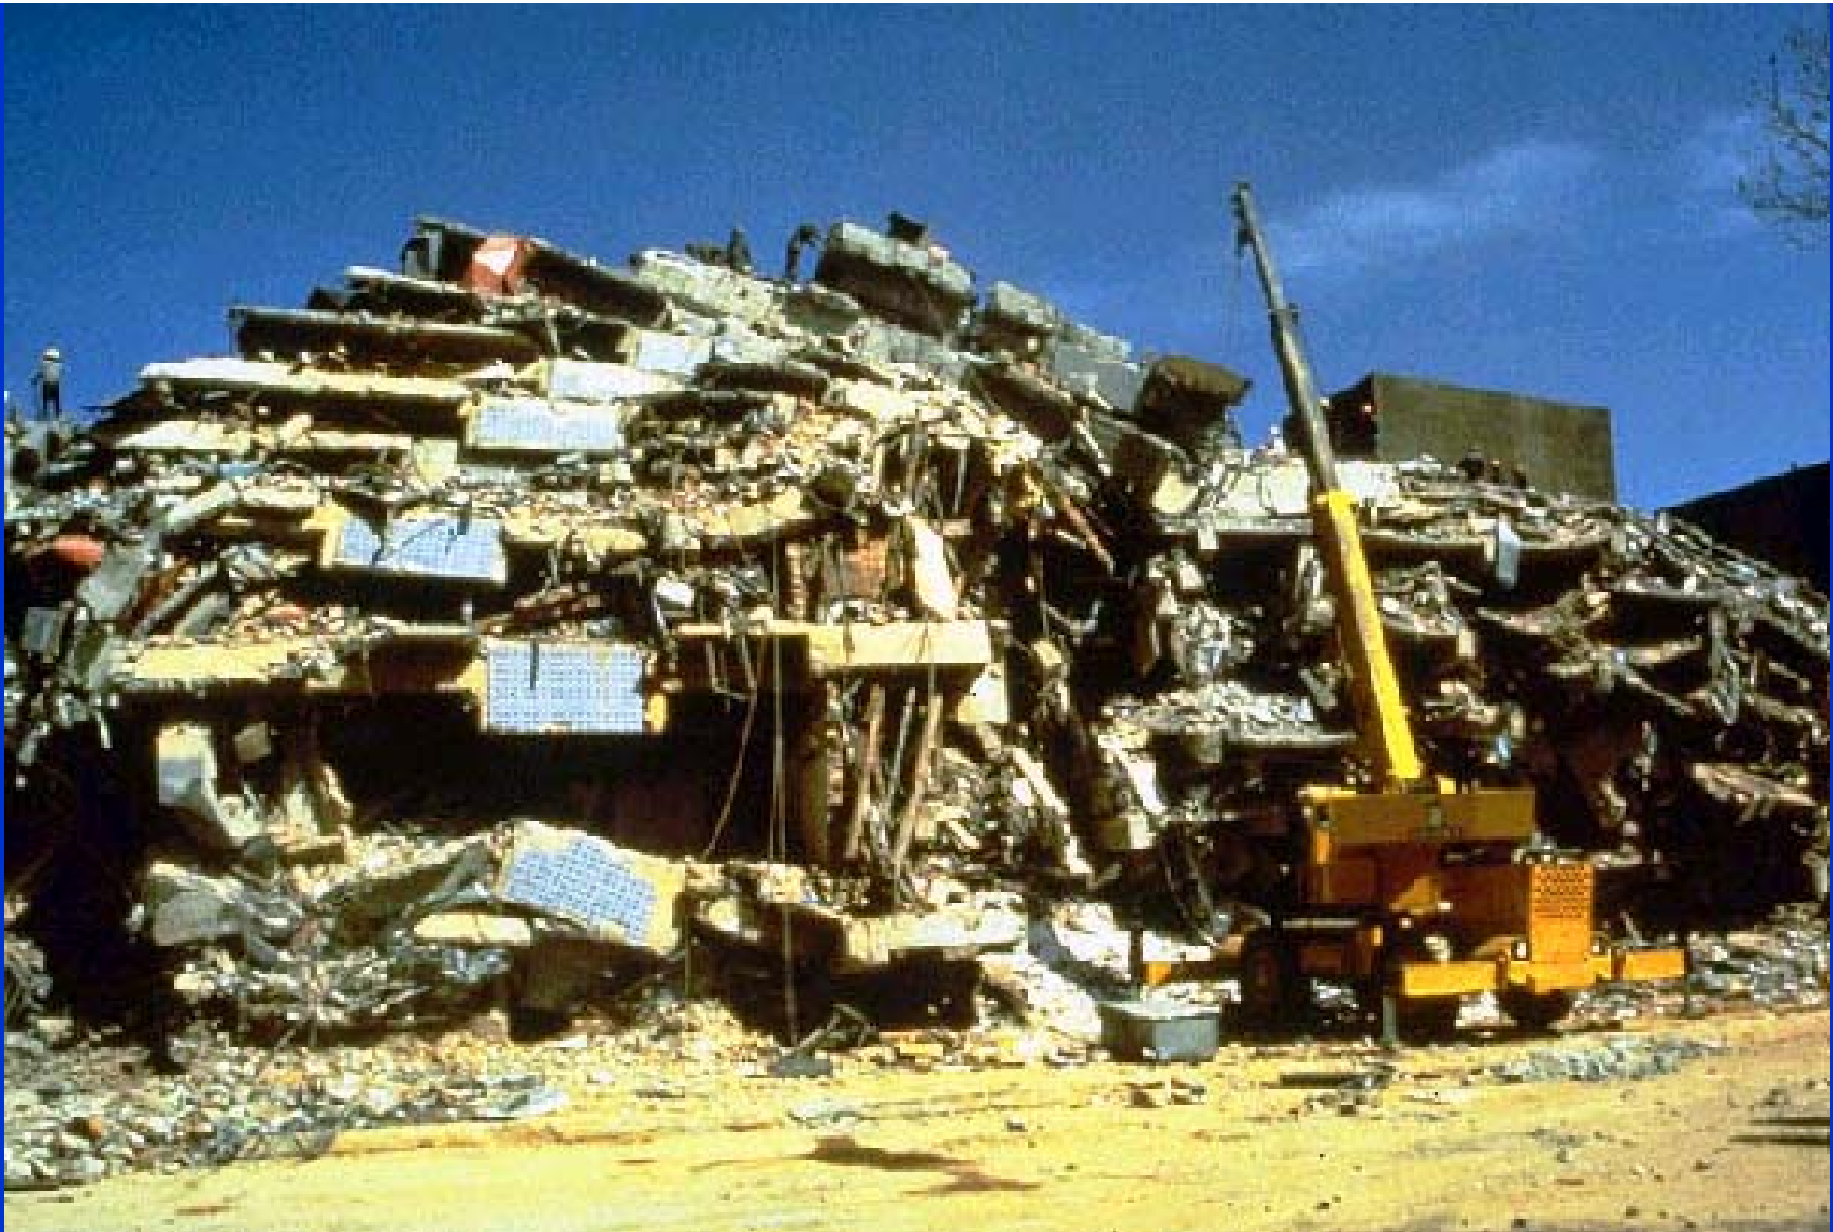
1985 Mexico Earthquake (Hospital Juarez, Mexico City)

Collapse of hospital. Several hundred persons were trapped in the maternity ward of the reinforced concrete structure.

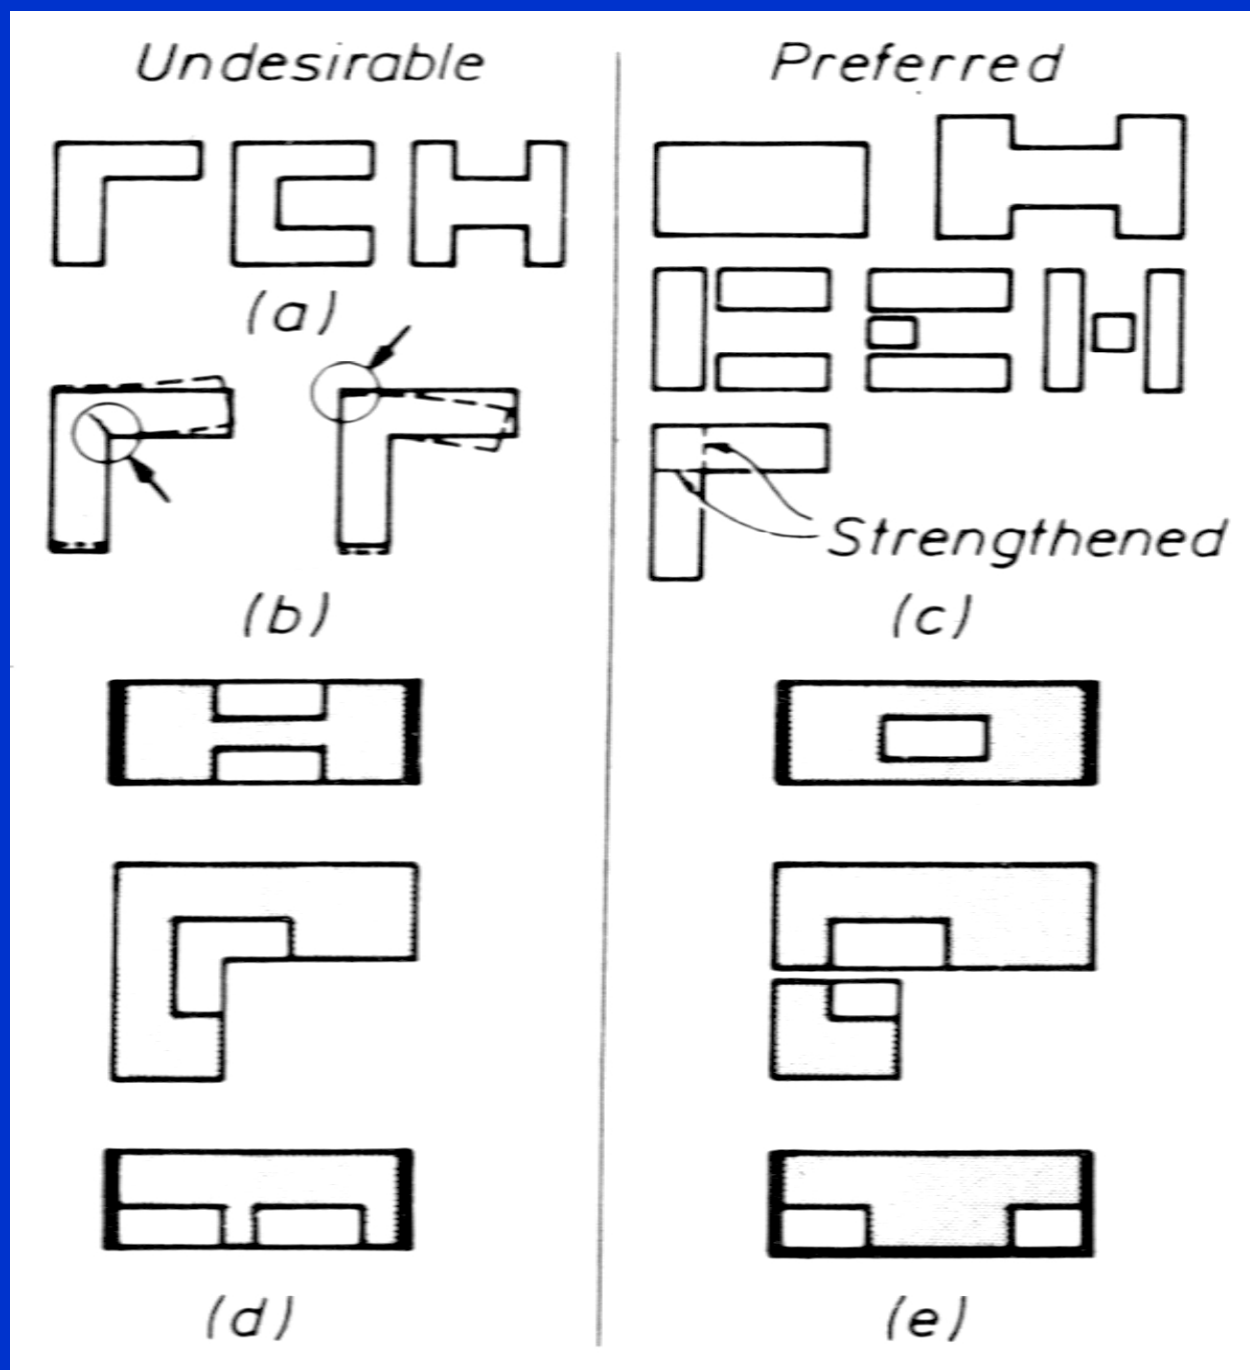
ตัวอย่างรูปแบบแปลนอาคารที่ควร
เลือกและไม่ควรเลือก

**Simple rules for plan
layouts of aseismic
buildings.(Only with
dynamic analysis and
careful detailing should
these rules be broken)**

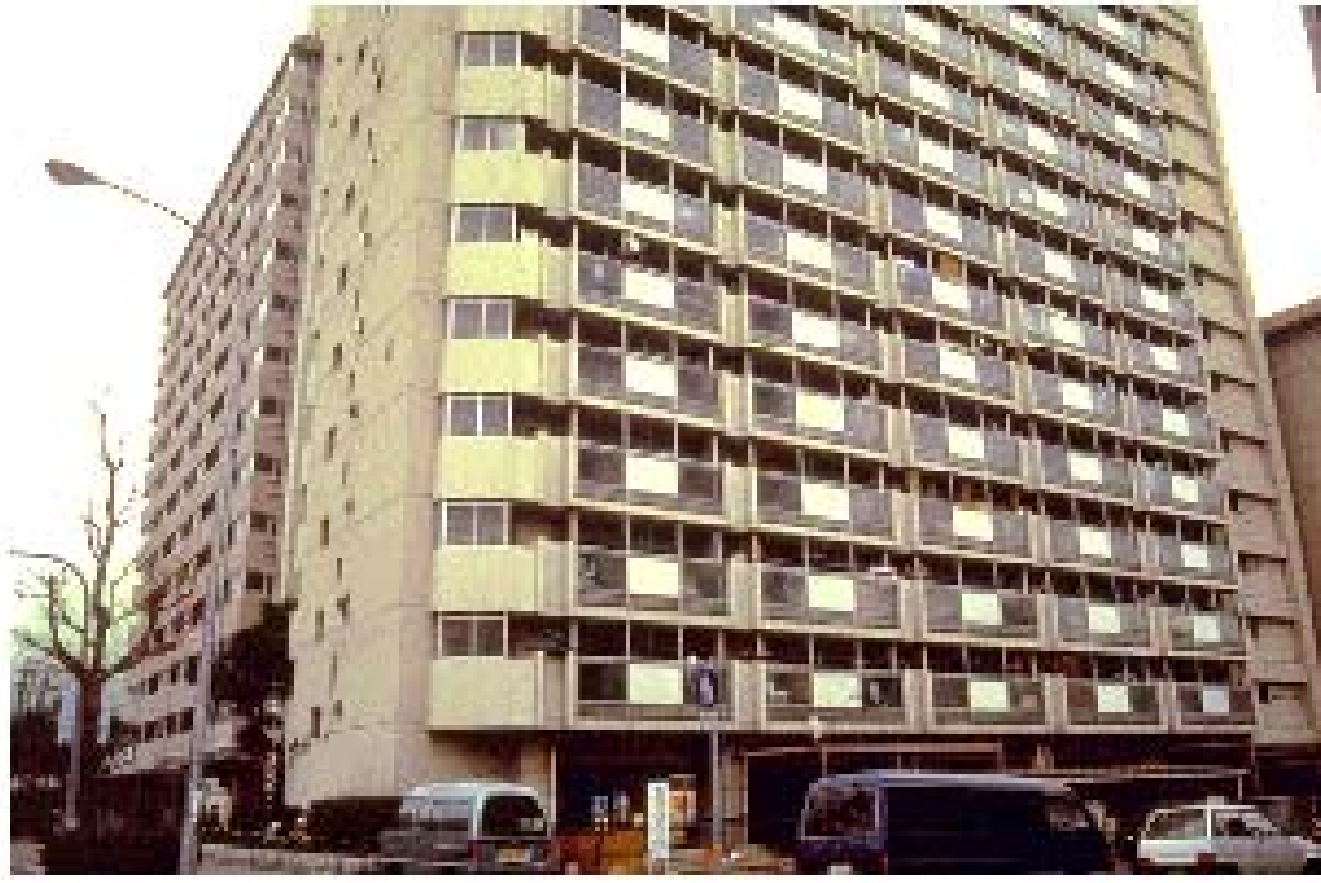
Pre-1971 Concrete Frame Buildings

Examples of damage to concrete shear wall buildings. Older well-configured shear wall buildings, such as these generally performed well relative to life-safety protection.
